Hello! Good morning. Hope you're enjoying our 2024 convention!

My goal today is to discuss the accidents that have occurred since our Colorado Springs Convention last year, and then try to put them into the larger context of our mission of improving safety.

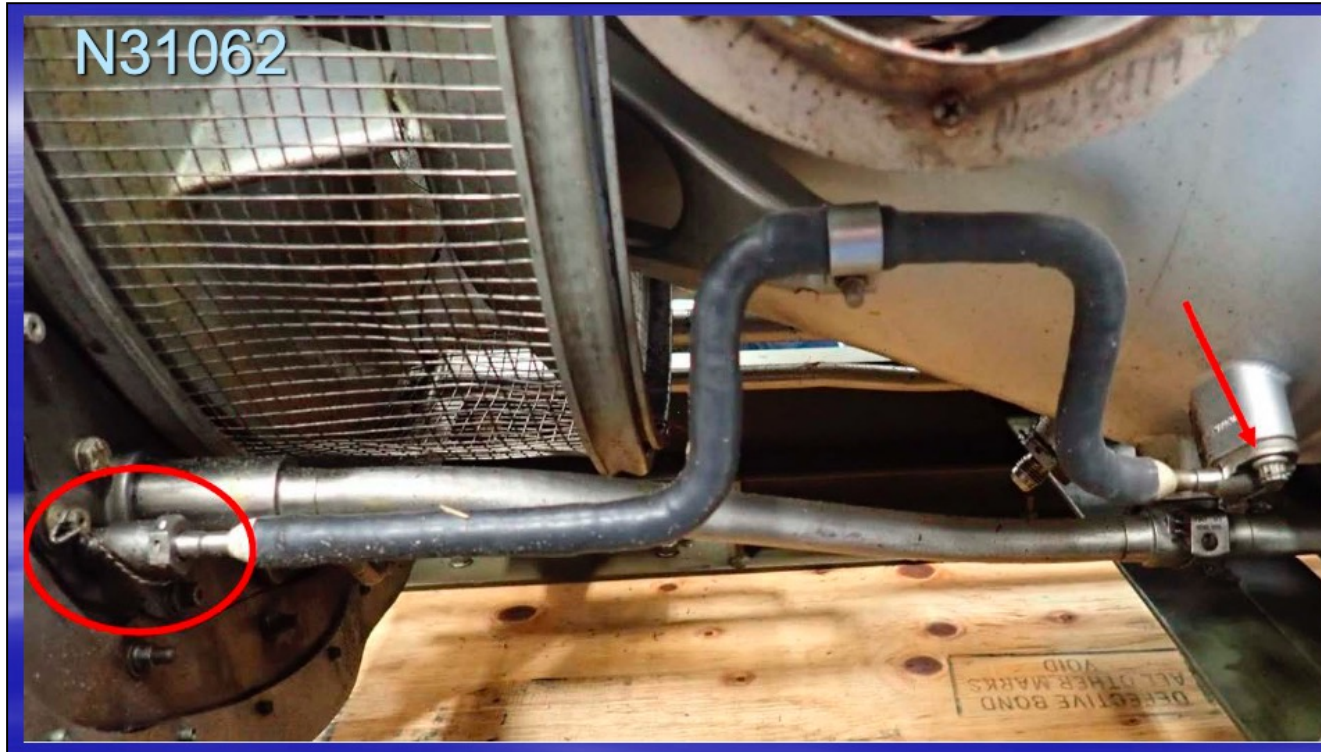
This picture is from the NTSB final report, and shows the P3 line in the engine compartment.

If you get a leak in the P3 line, the fuel controller will sense less airflow through the engine, thus causing it to reduce the fuel supply, even down to low idle.

The circle on the left shows the attachment that leads to the fuel controller.

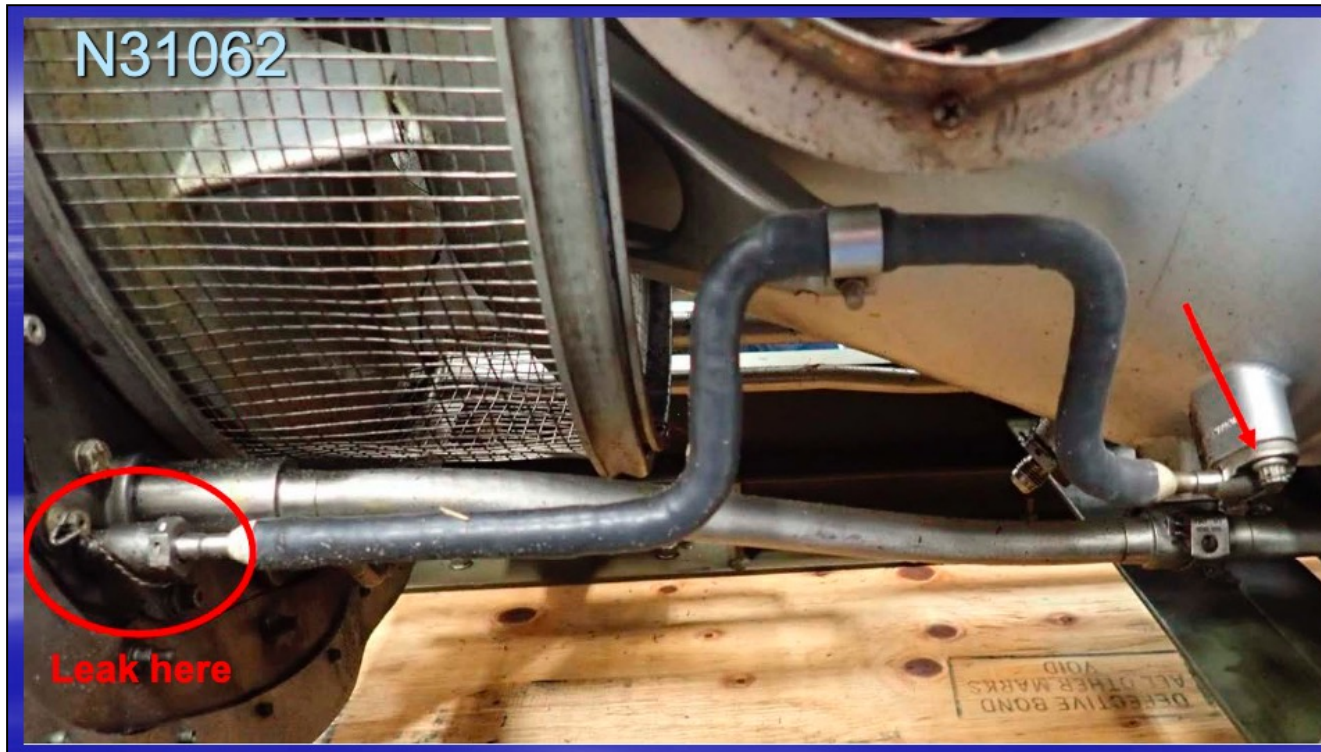
What happened in our accident plane was the P3 connection in the circle was loose, allowing a leak, which is what caused the power loss.

So this is a good example of a perfectly functioning engine, and a perfectly functioning fuel controller, sabotaged by a leak in a pressure line.

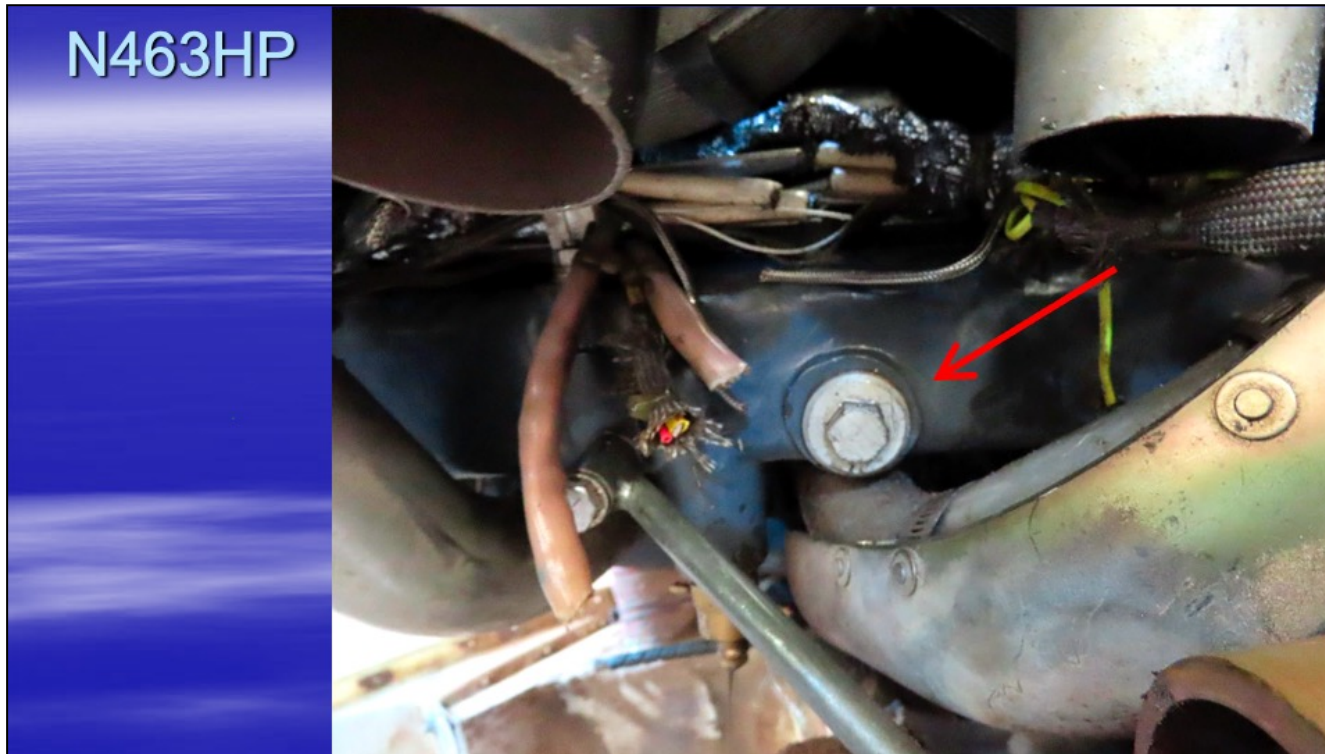
This is the oil sump plug after the accident.

The plug was found with no safety wire, and loose, not even finger tight.

The mechanic's failure to properly secure the oil suction screen plug during recent maintenance, which resulted in an oil leak and subsequent loss of engine power due to oil starvation.

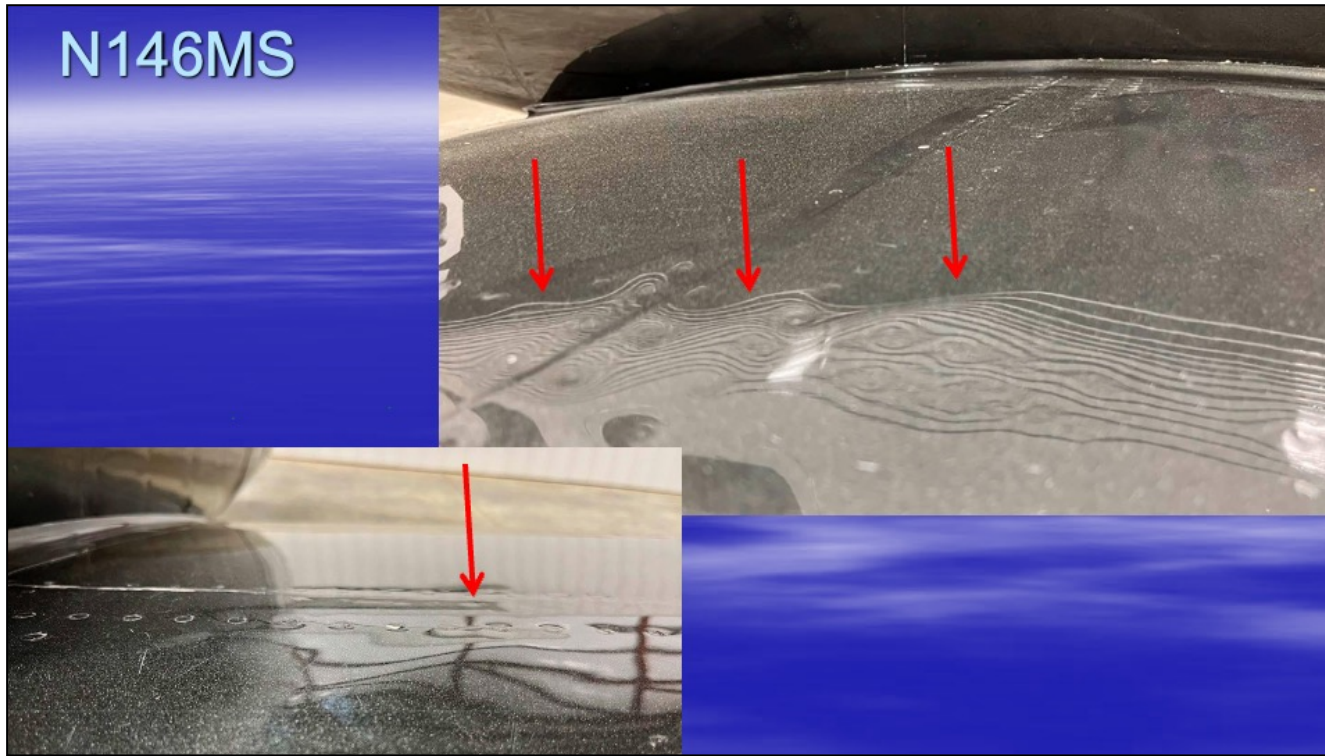
The pilot, and subsequently an FAA inspector, did a walkaround, and found some concerning wing issues.

The insurance company sent a mechanic, who diagnosed significant wing root damage, and the insurance company totaled the plane.

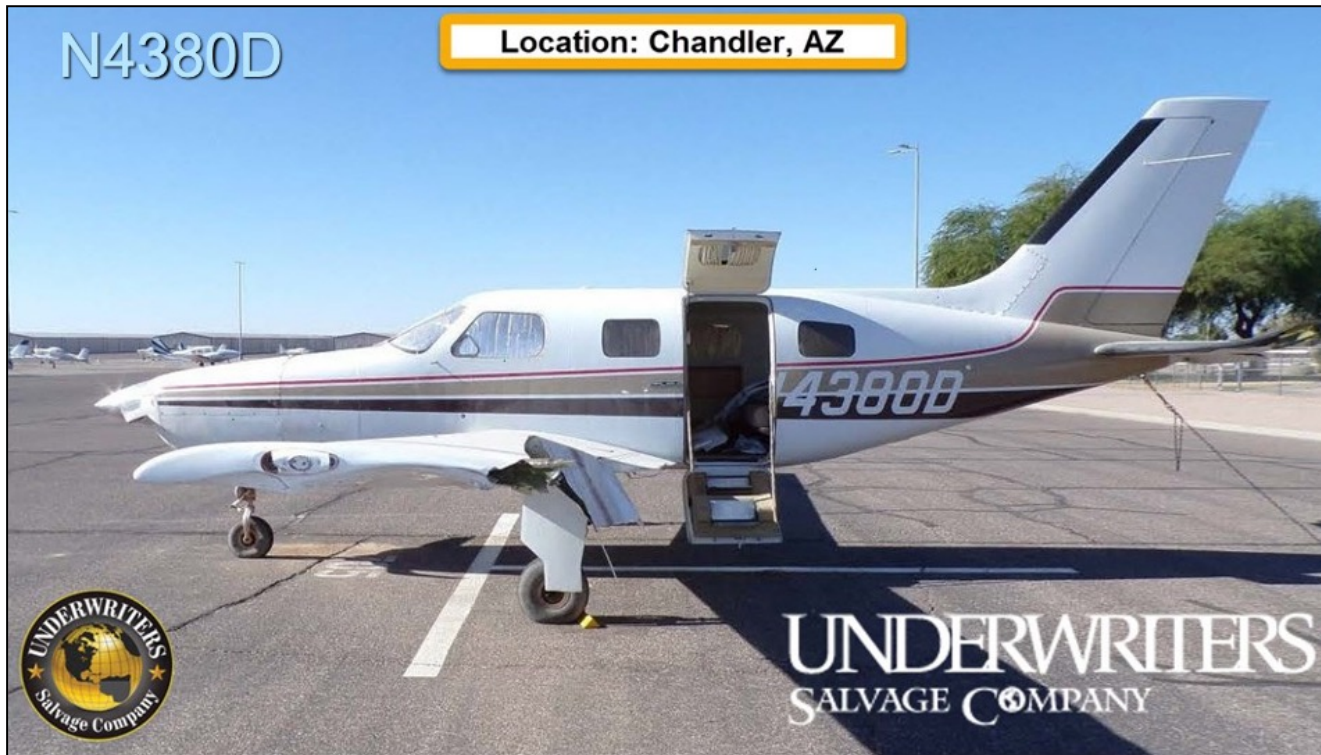
There was significant damage to the left aileron.

The FAA inspector noted that there was no useable fuel at all in the tanks, but the JPI engine monitor indicated 32 gallons remaining...

This picture is of the plane post-accident, and shows the left aileron damage.

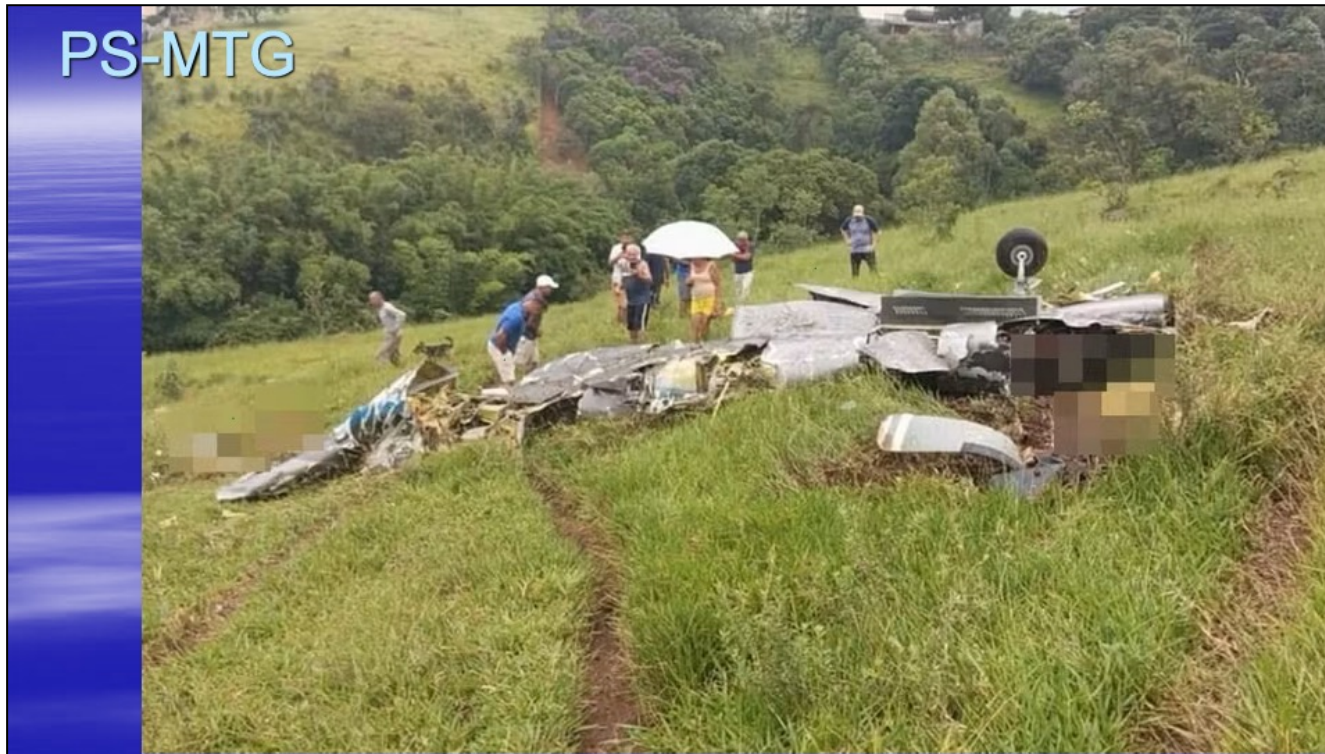
This was the fuselage wreckage.

Wings and tail were found a good ways off.

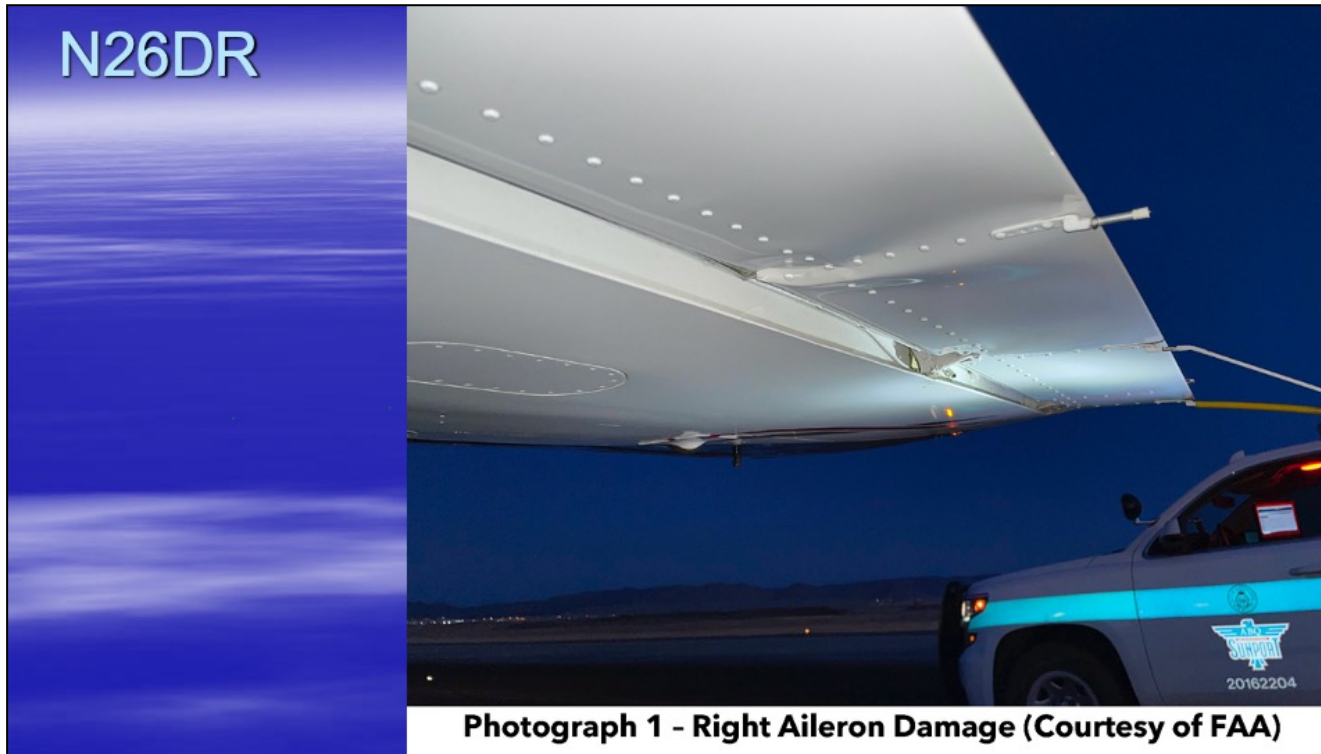
On landing, the plane got a flat tire on one of the mains, causing it to veer off the runway.

Unfortunately, the plane hit a runway light, which damaged the right aileron, which is why this event is listed as an accident, rather than an incident.

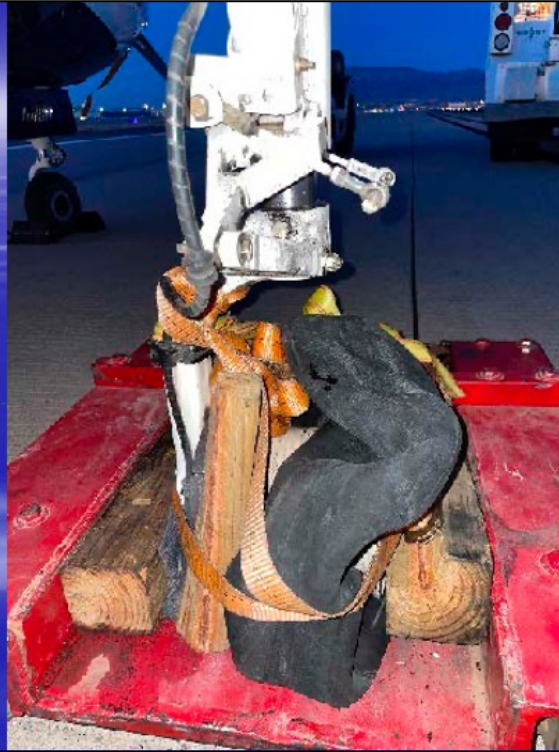
The flat tire was pretty mangled.

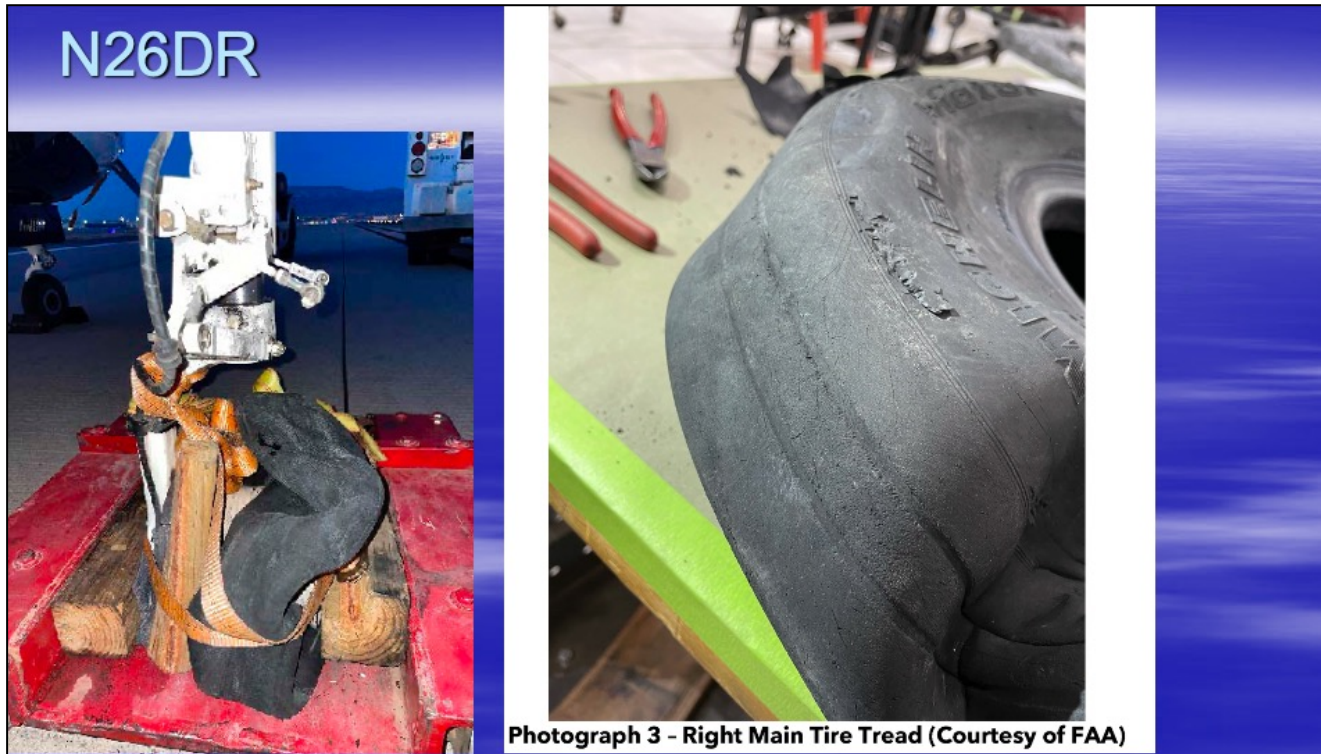
The NTSB noted that the tire was very worn, as shown here, and considered this a contributing factor.

The tire was about a year and a half old, and the pilot had been planning to have it replaced at his next annual.

I guess the lesson here is keep your tires in good condition by replacing them when worn.

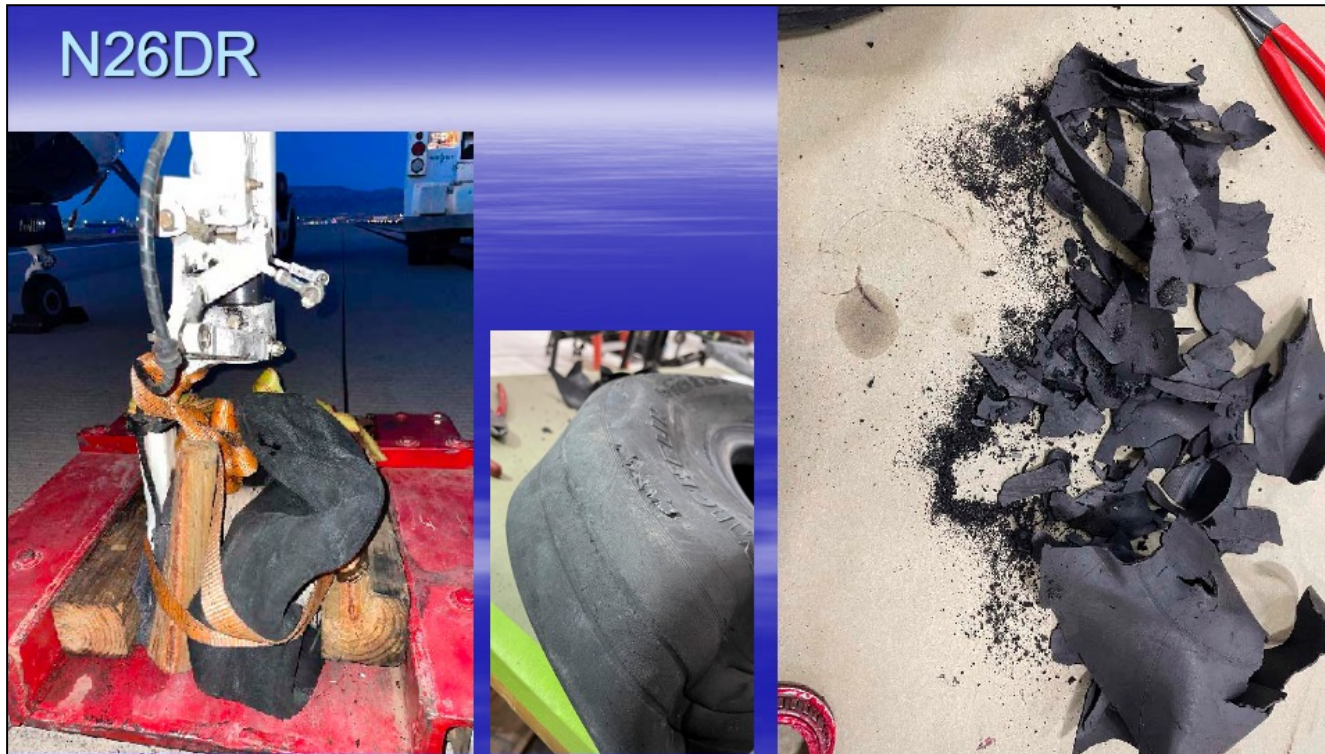
The inner tube was totally fragmented, as shown in this final photo.

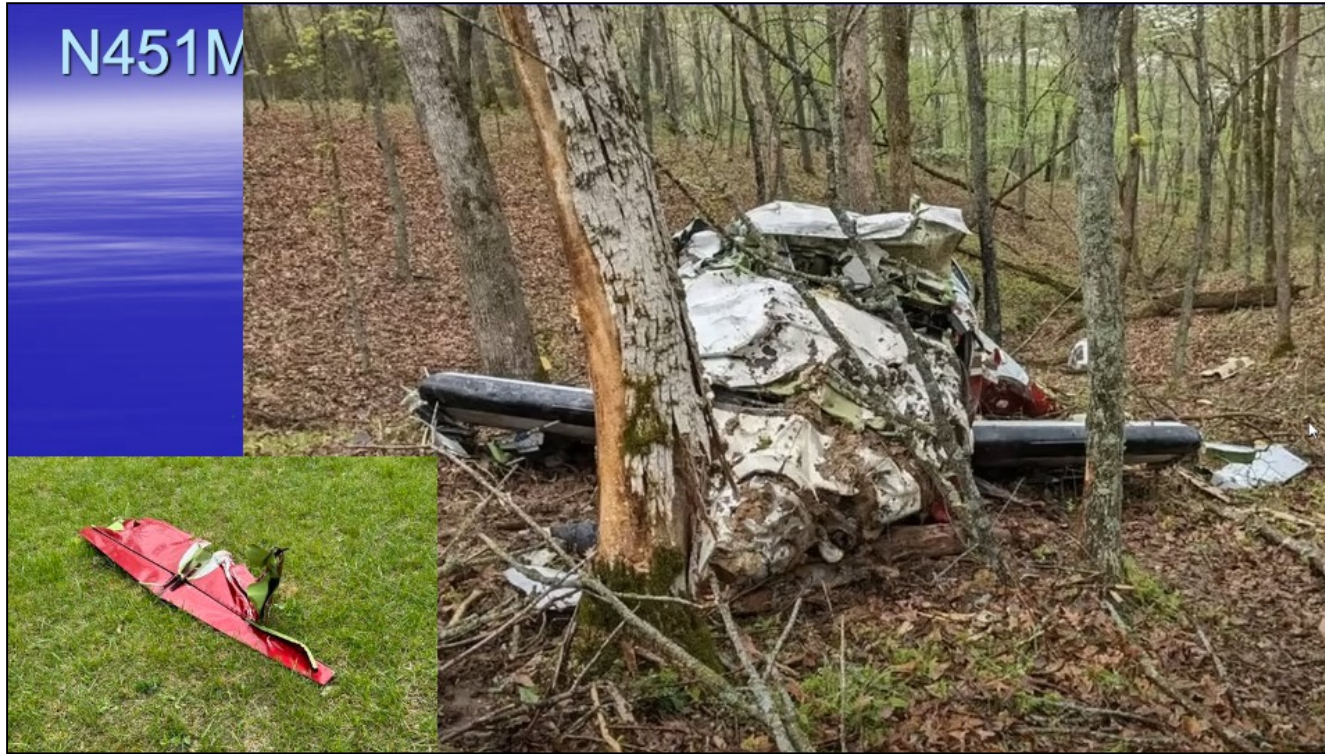
Regardless of cause, the plane shed its outboard wings and tail, and the fuselage hit the ground in an almost vertical path.
