Hello! Good morning. Hope you're enjoying our 2024 convention!

My goal today is to discuss the accidents that have occurred since our Colorado Springs Convention last year, and then try to put them into the larger context of our mission of improving safety.

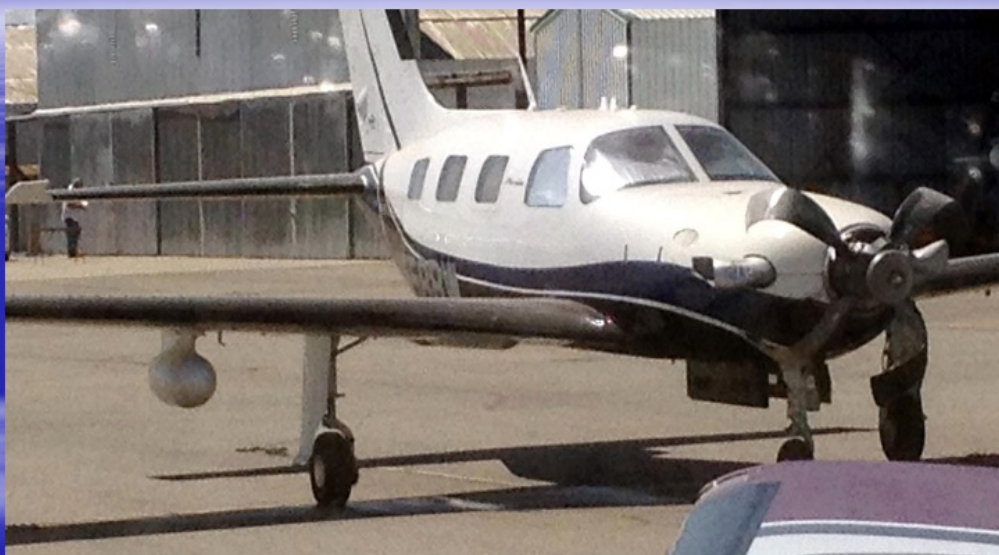
So under that definition, this gear up landing never made it into the accident database.

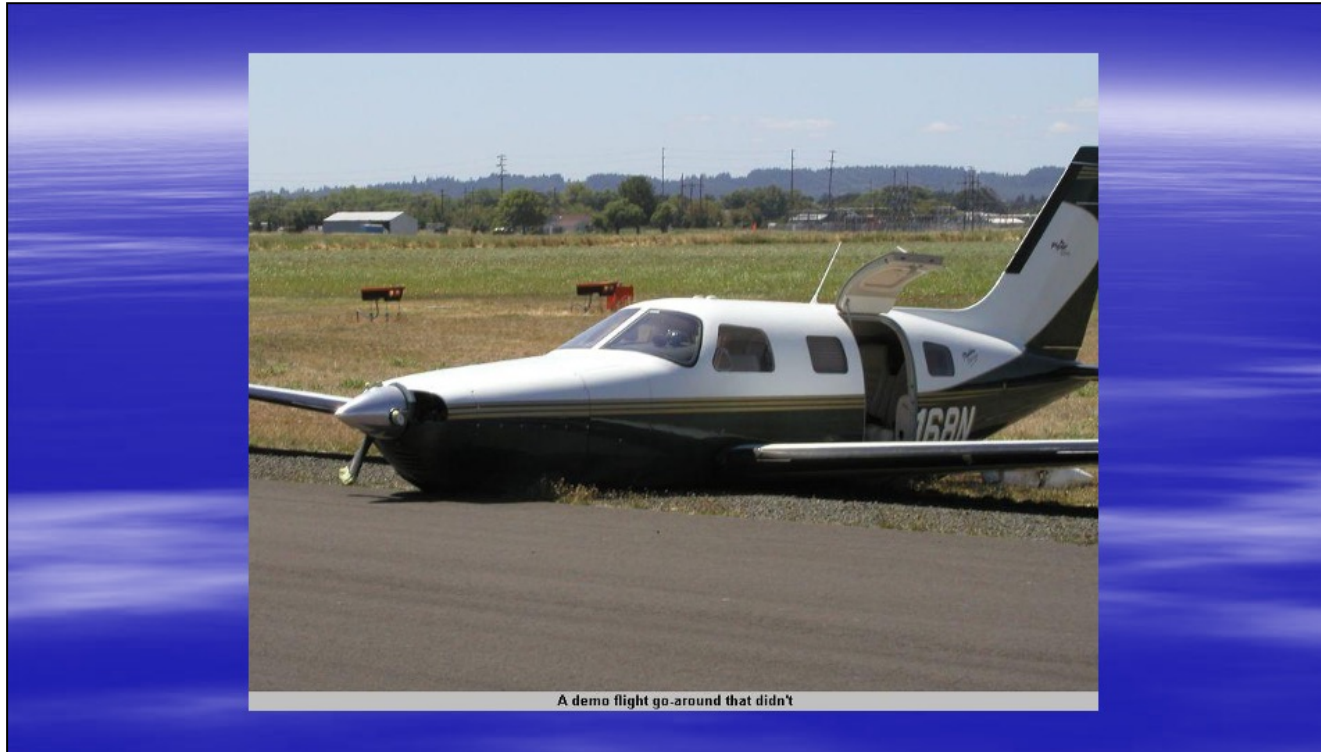
Nor did this botched go-around.

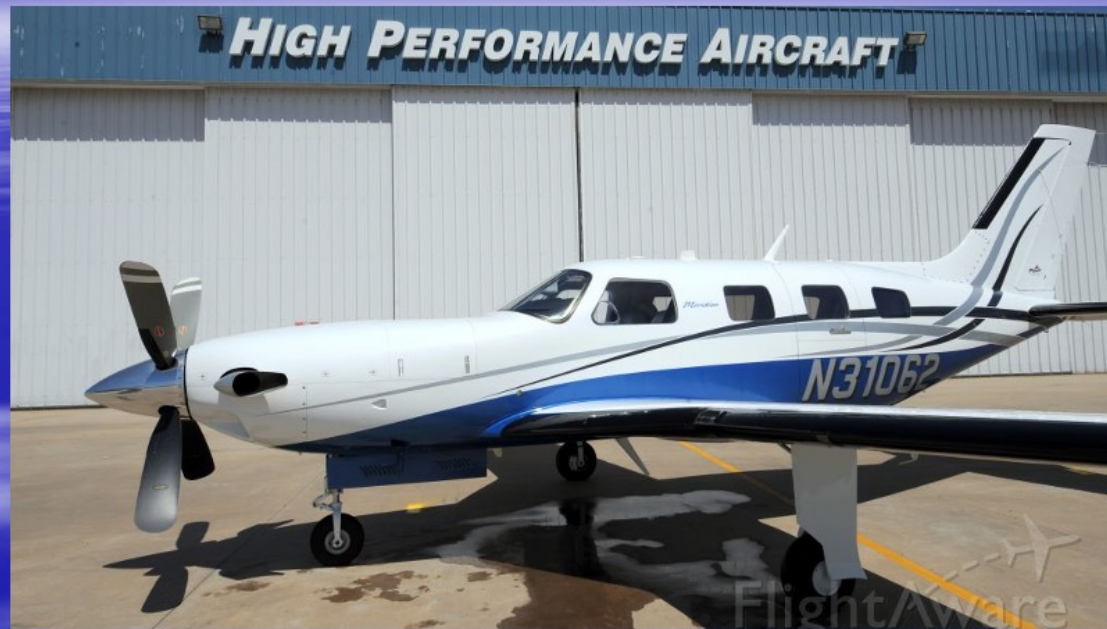
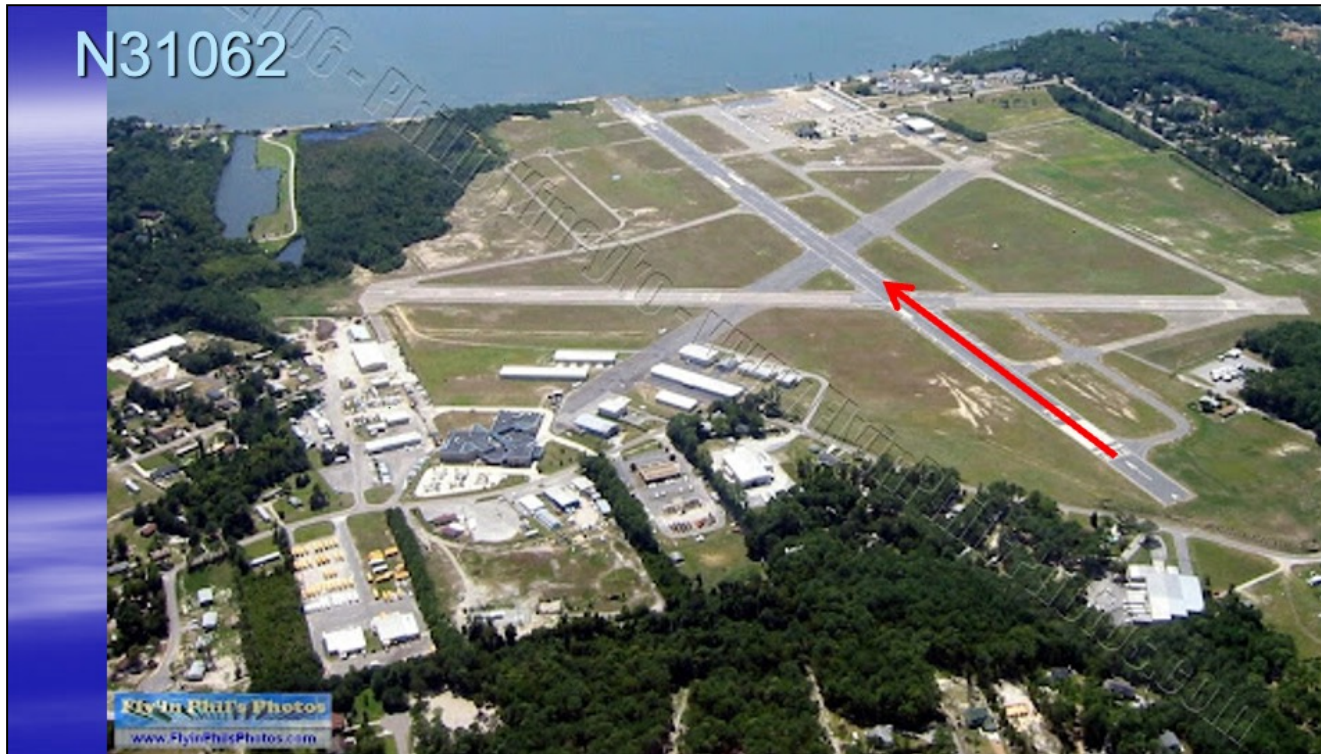
N31062

This is a 2005 Meridian.

The ATP-rated pilot and his passenger were taking off from runway 23 at Manteo, North Carolina.

After gear retraction, there was a loss of engine power. This was temporarily fixed using the MOR lever, and the pilot turned back to the airport.

If you get a leak in the P3 line, the fuel controller will sense less airflow through the engine, thus causing it to reduce the fuel supply, even down to low idle.

What happened in our accident plane was the P3 connection in the circle was loose, allowing a leak, which is what caused the power loss.

So this is a good example of a perfectly functioning engine, and a perfectly functioning fuel controller, sabotaged by a leak in a pressure line.

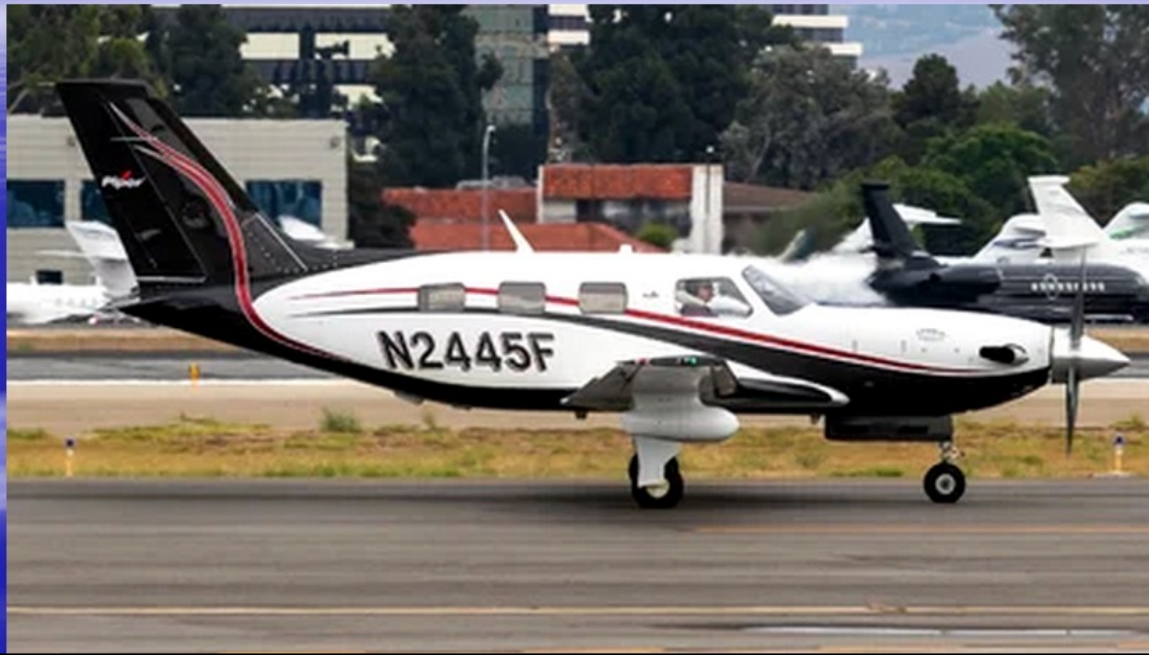
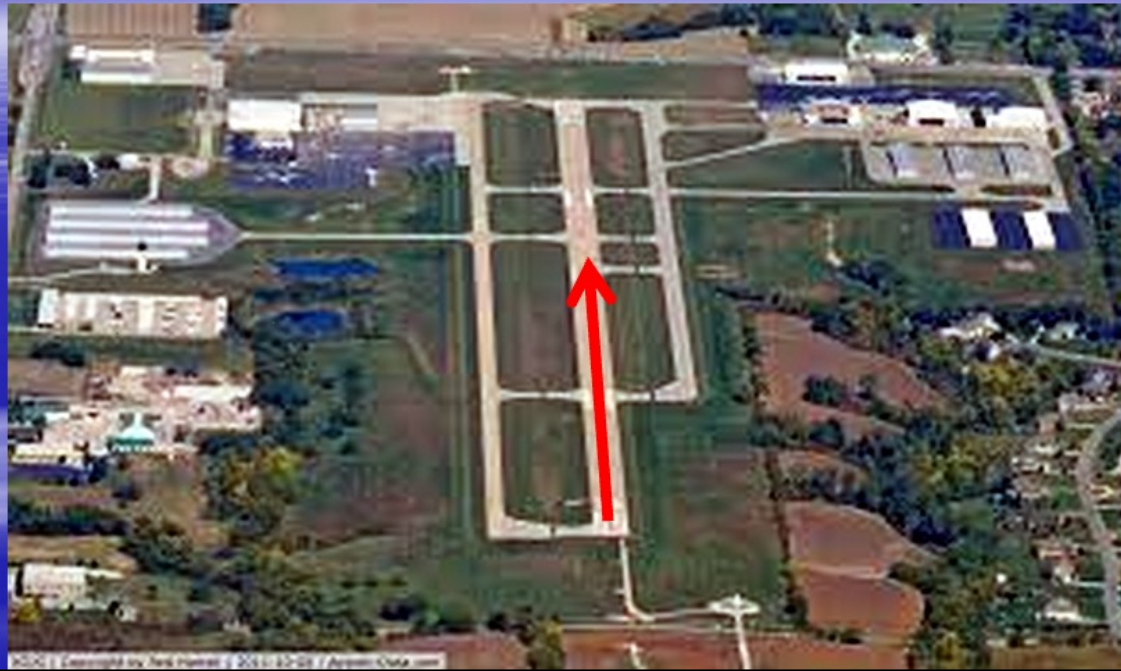
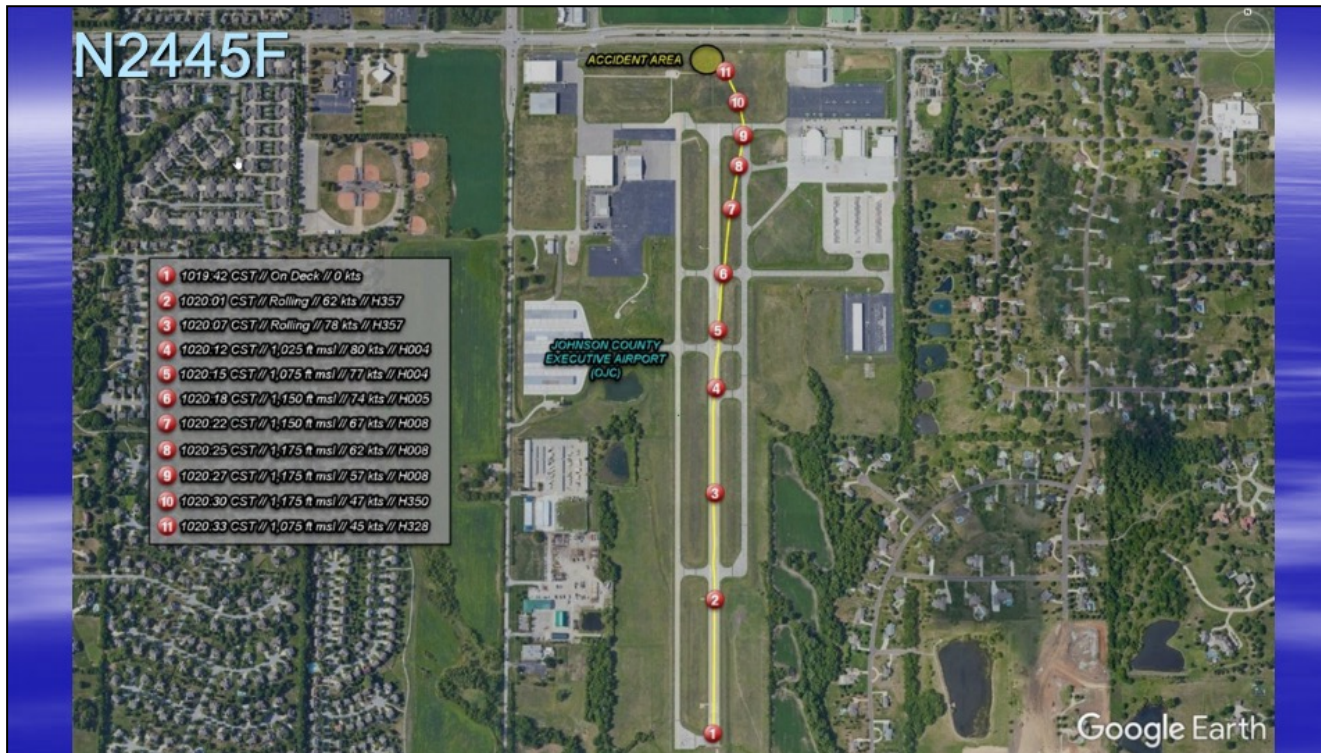
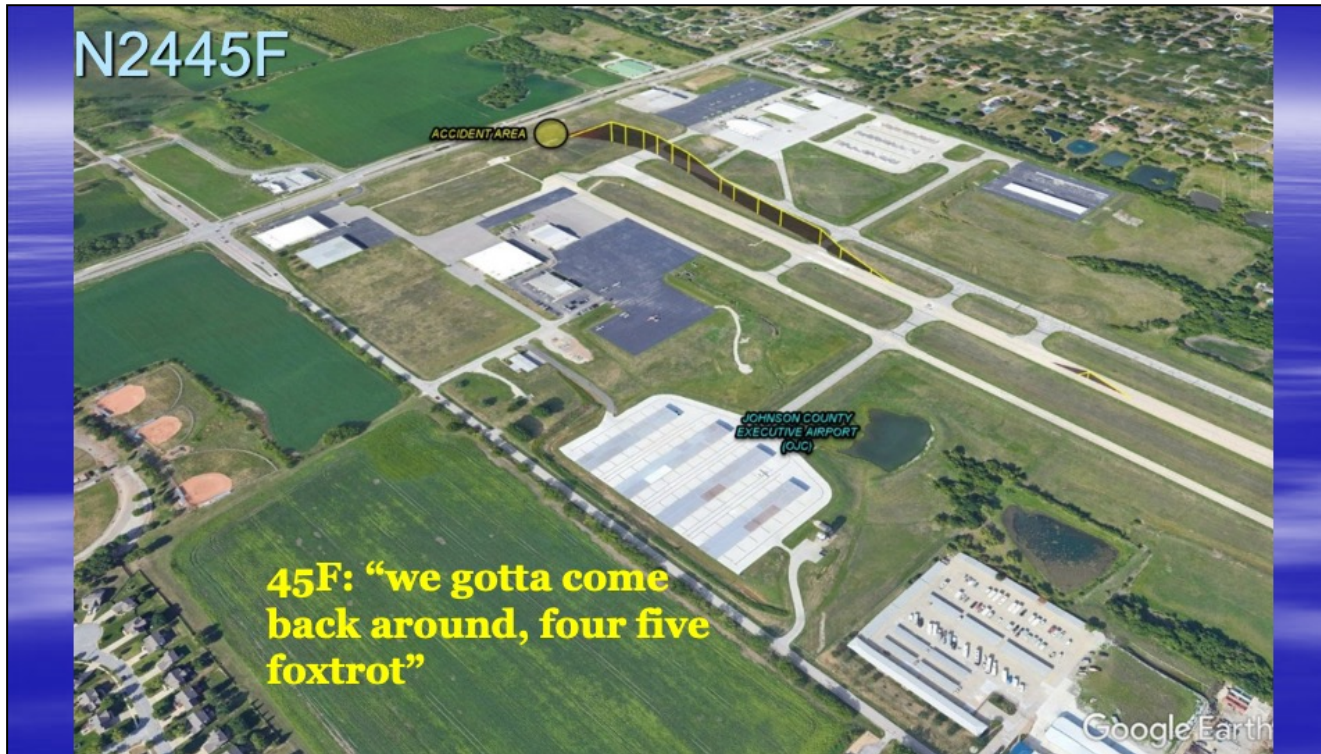
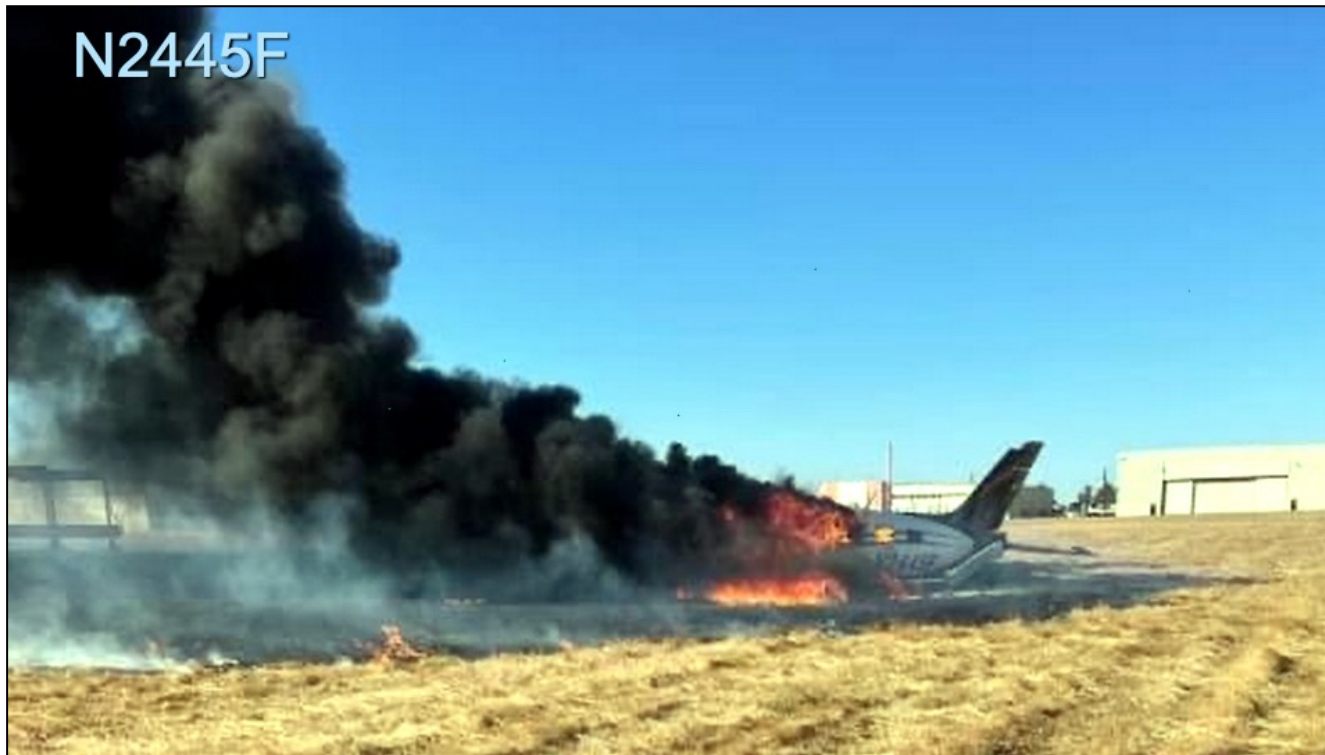
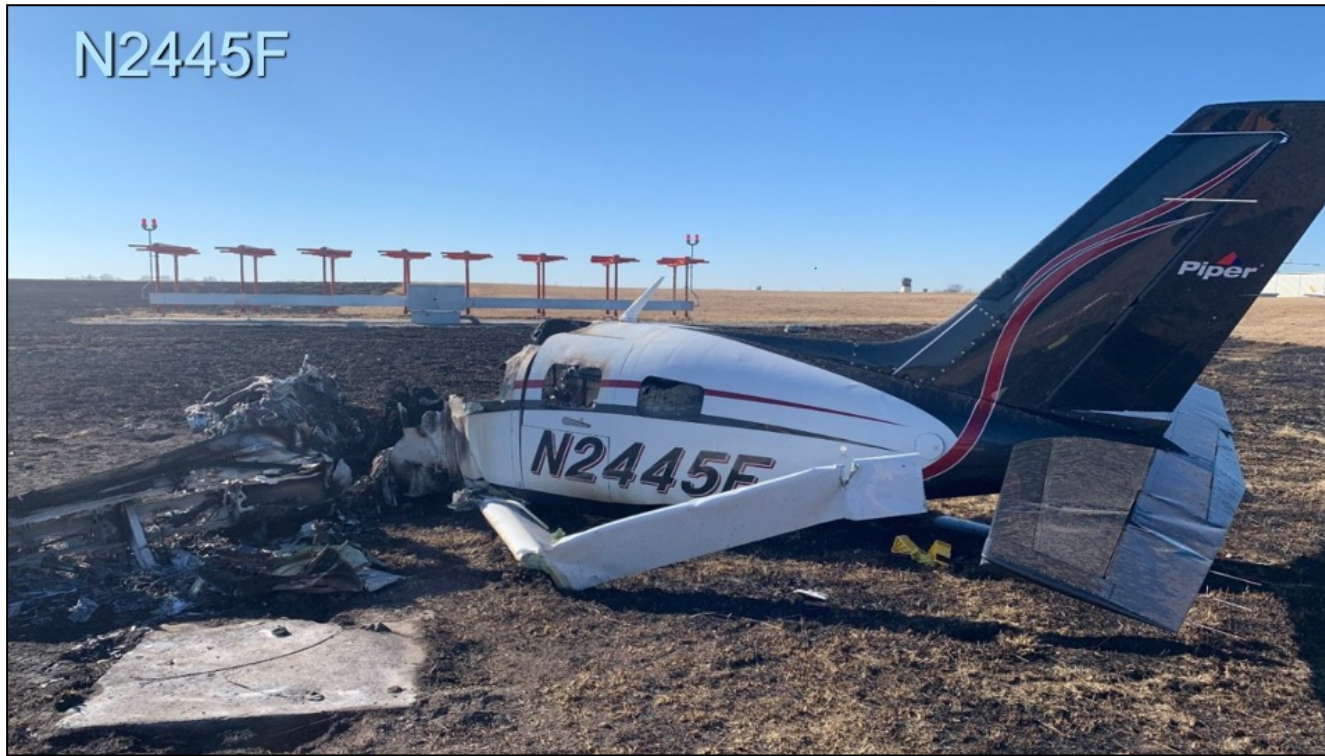
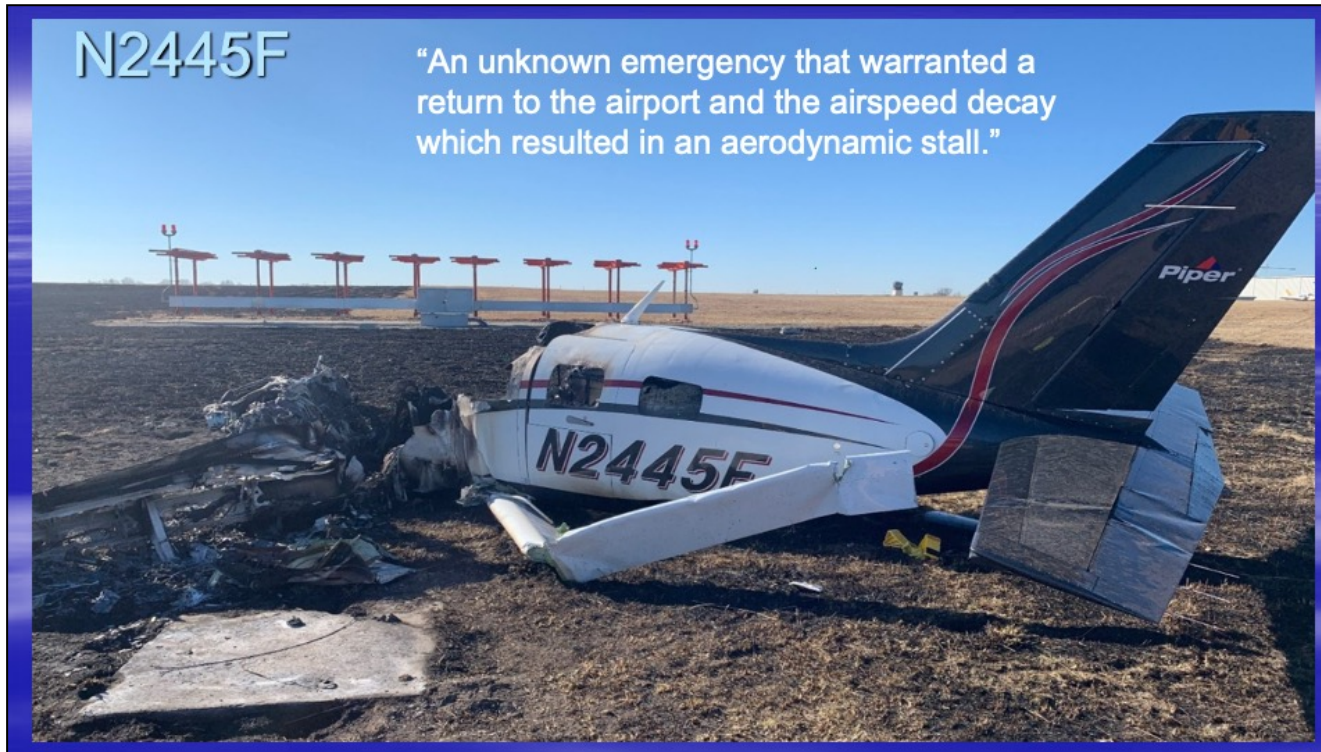
N2445F

Many of you likely remember this awful accident.

This 2012 Meridian was in O-lay-thuh (~~Olathe~~) Kansas for an annual.

After completion of the annual, the owner-pilot was departing on runway 36 for home.

The plane reached a groundspeed of 80 knots, lifted off and climbed a little.

Shortly after liftoff, the pilot radioed the tower with an urgent need to return to the airport.

The plane had reached a maximum altitude of about 125 feet AGL, with steadily decreasing airspeed. So this was what is often referred to as the “impossible turn”.

As the plane turned back, the airspeed continued to decay, down to an airspeed of about 60.

The plane then stalled and crashed 400 feet past the end of the runway.

Total time from takeoff to crash was only 21 seconds.

The front of the plane burned on crashing, and the pilot was killed.

When I originally presented this crash, I was skeptical that the NTSB would be able to learn much about what happened, given the extensive fire damage to the entire front of the plane.

And unfortunately that's the case. Final cause is listed as: "An unknown emergency that warranted a return to the airport and the airspeed decay which resulted in an aerodynamic stall."

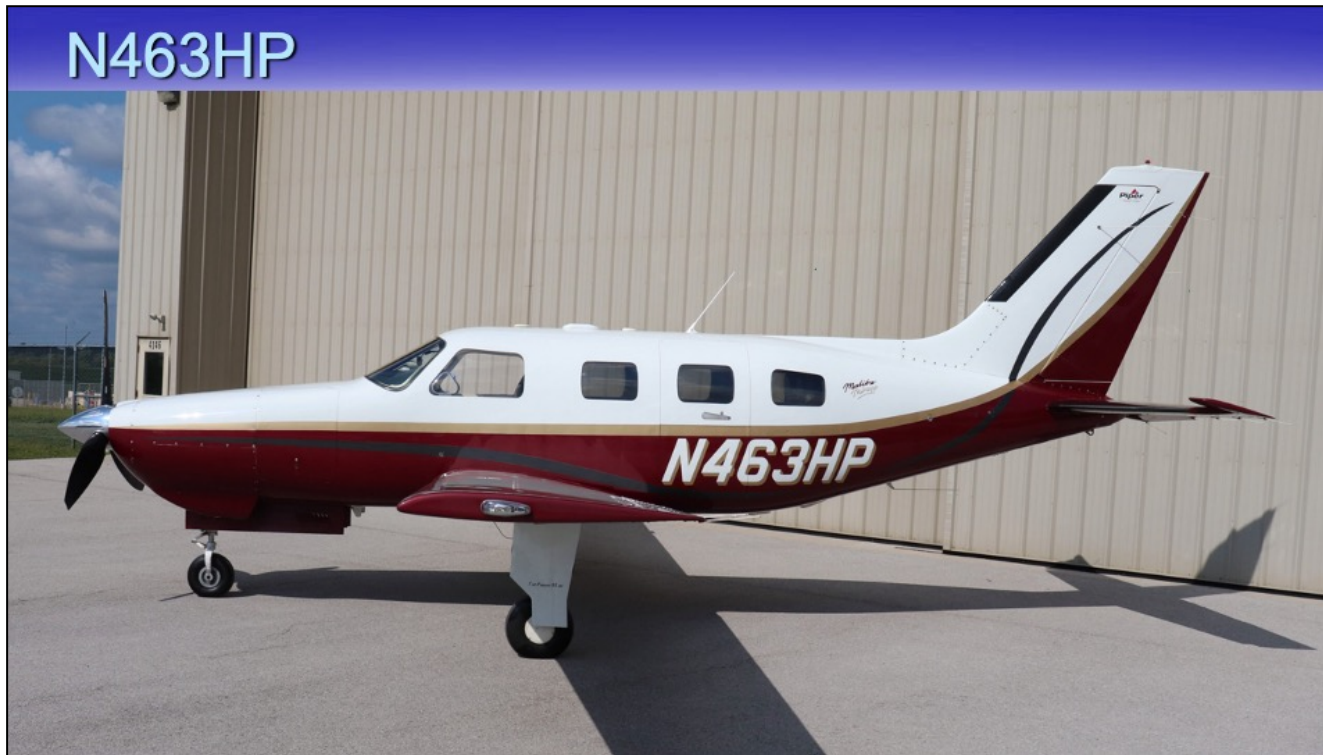
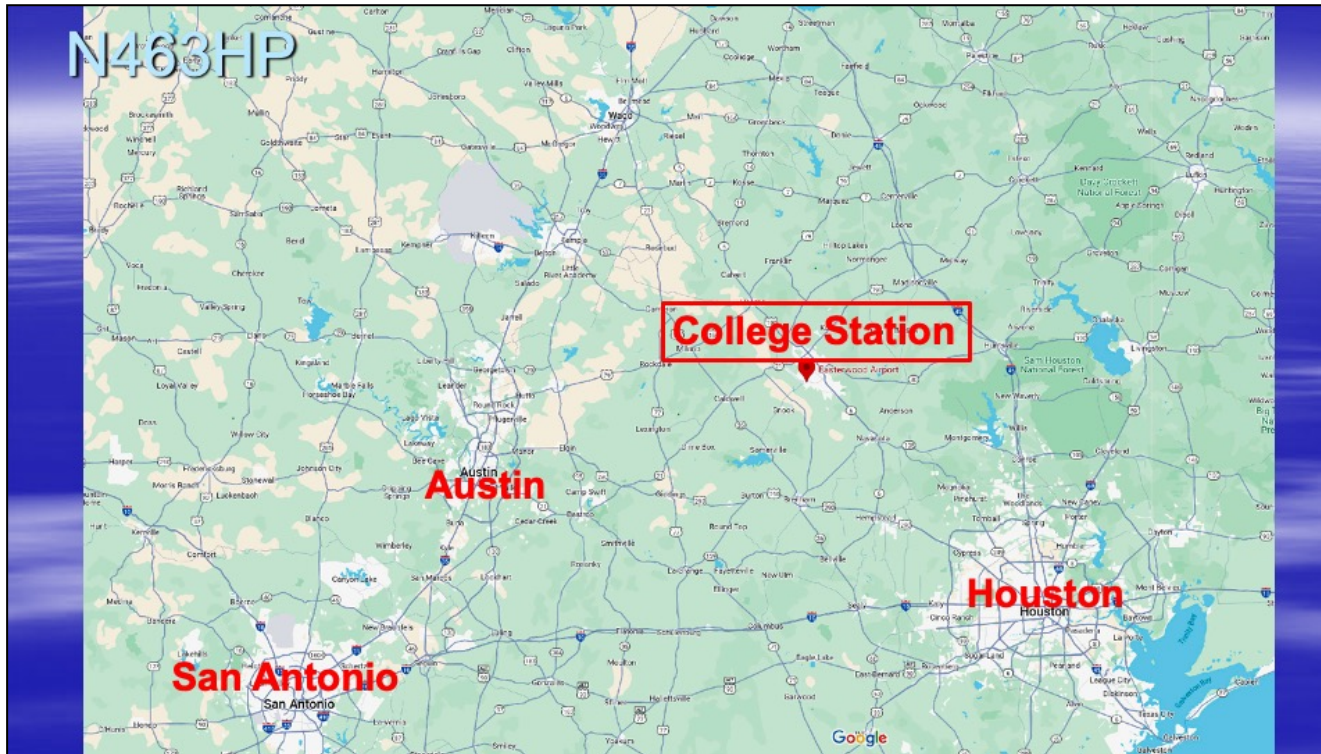
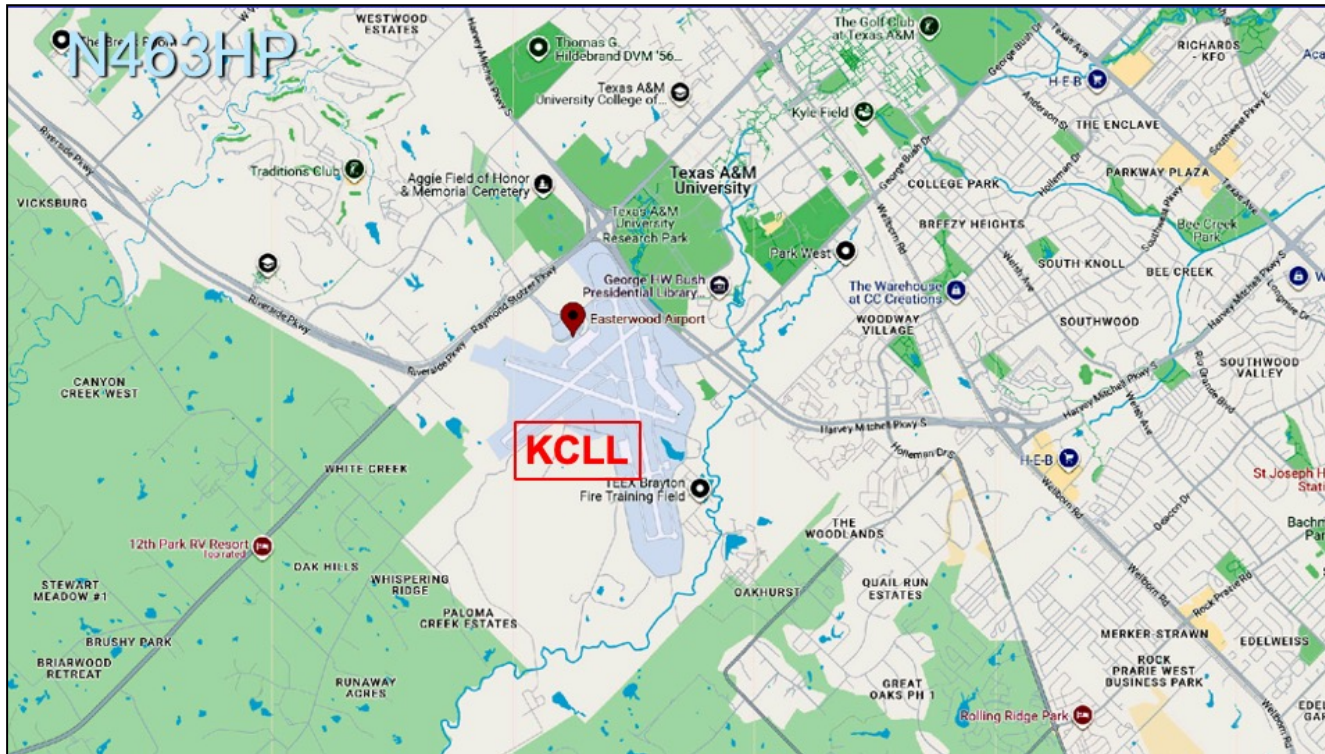
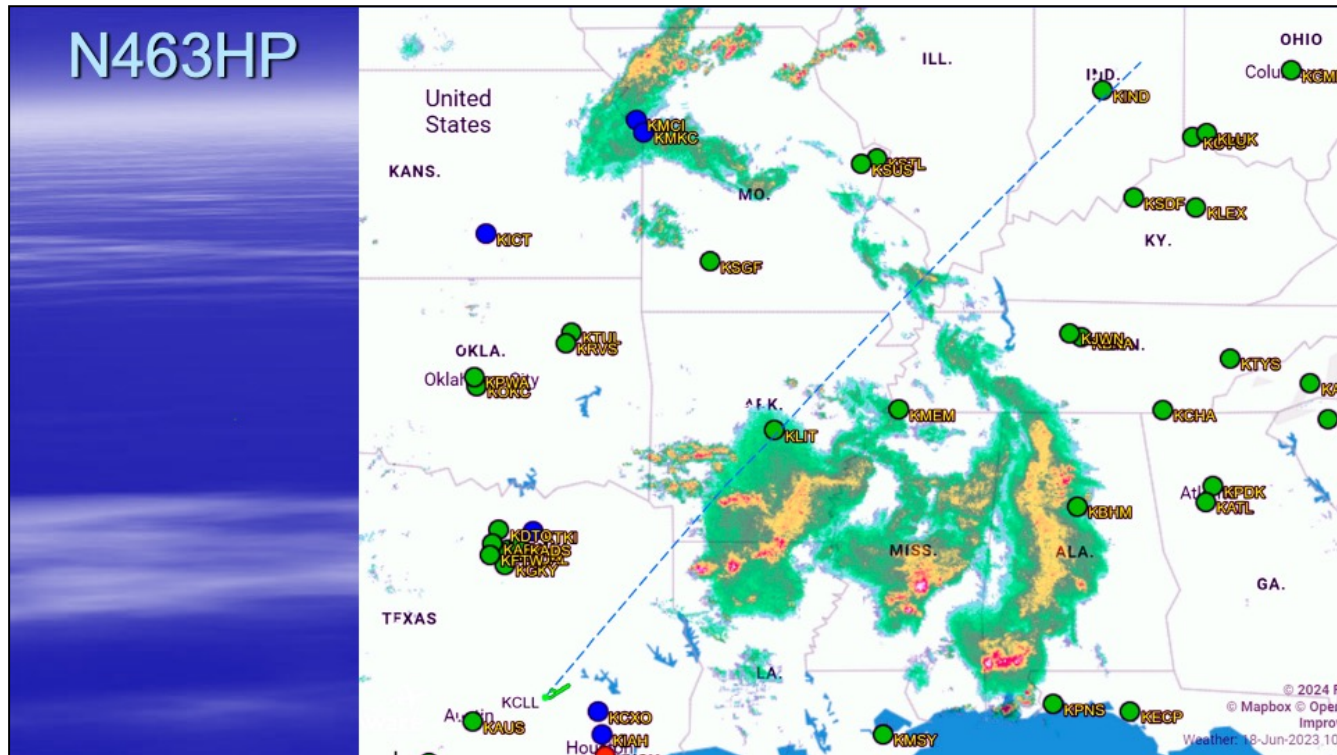
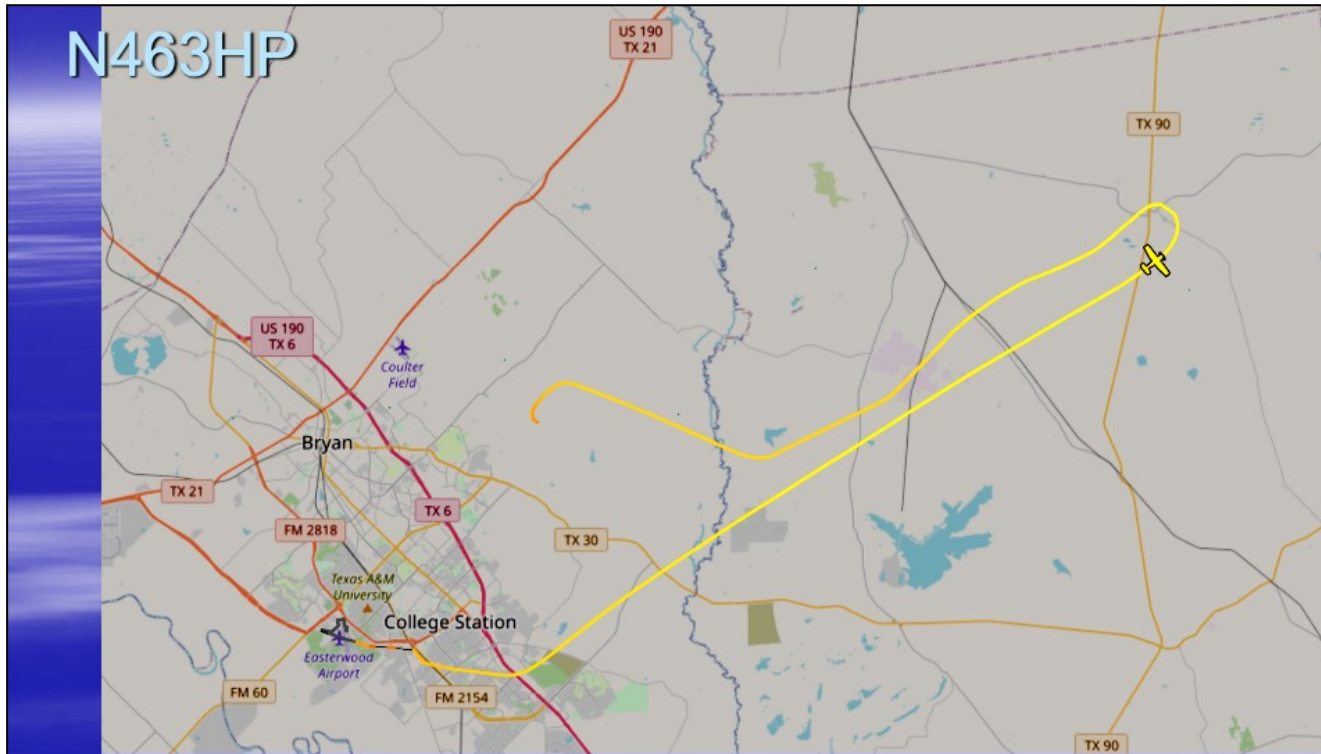
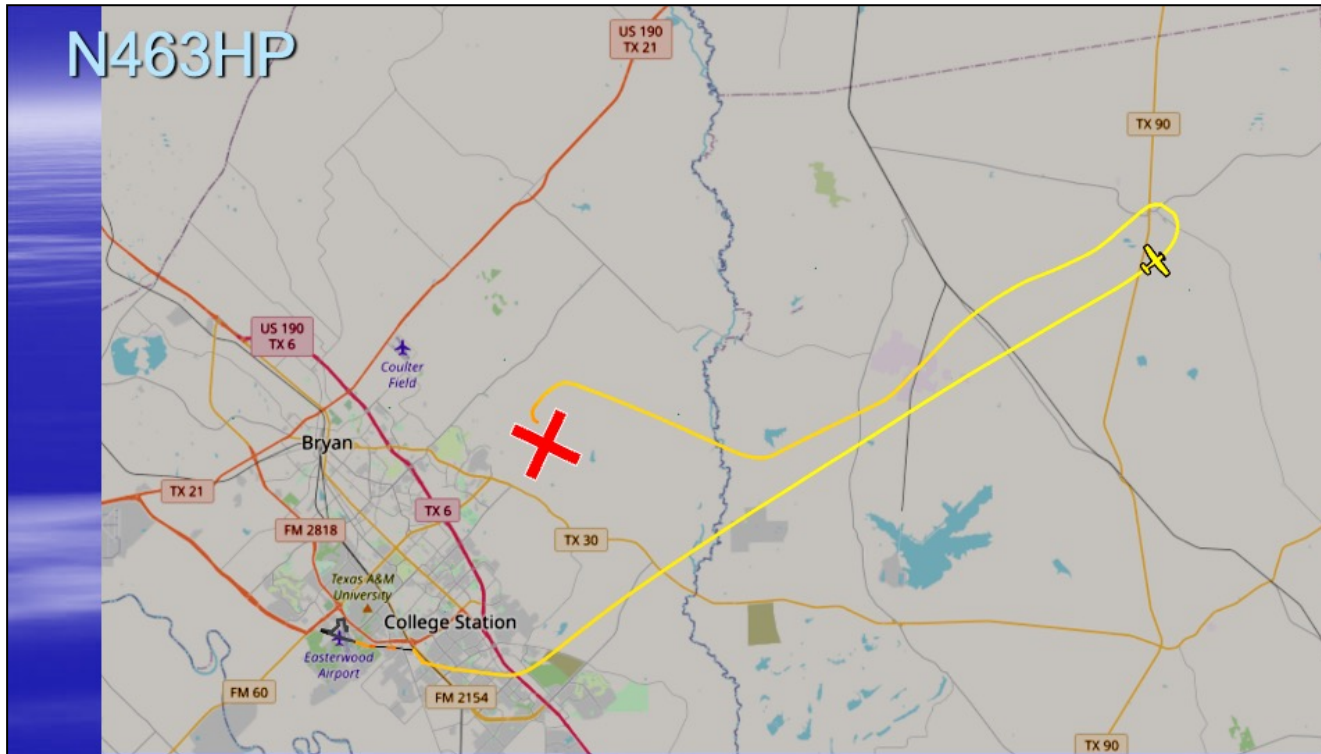
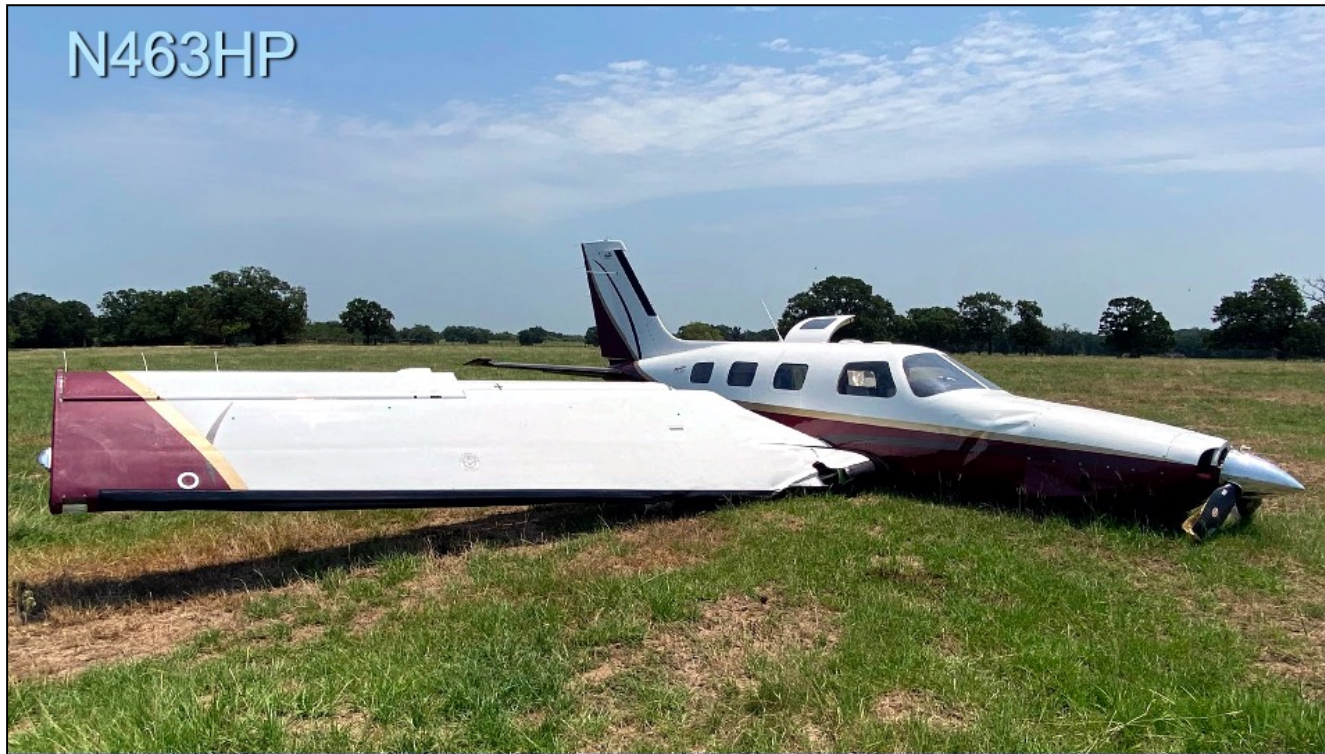
N463HP

This was a 2002 Mirage.

A month later, the plane had an oil and filter change, again as shown here.

Note the documentation that a new safety wire was placed, which would have been on the oil sump plug.

2 months later, and 11 days before the accident flight, the pilot was in cruise when he observed decreasing manifold pressure and a partial loss of engine power.

A mechanic there told the pilot the turbocharger required replacement.

The turbocharger was indeed replaced, and the mechanic at that time also changed the oil and oil filter.

The logbook entry shows the turbo replacement, as well as the oil and filter change, and noted that a runup was done and was normal.

You'll note that in this note there is no mention of safety wiring the sump plug.

While climbing through 4,000, the pilot noticed the oil temp began increasing above normal.

While on vectors for a GPS approach, he noted smoke in the cabin and a loss of engine power.

He couldn't reach the airport, and performed a forced landing to a field.

The plane was totaled, but the pilot walked away without injury.

The plug was found with no safety wire, and loose, not even finger tight.

The mechanic's failure to properly secure the oil suction screen plug during recent maintenance, which resulted in an oil leak and subsequent loss of engine power due to oil starvation.

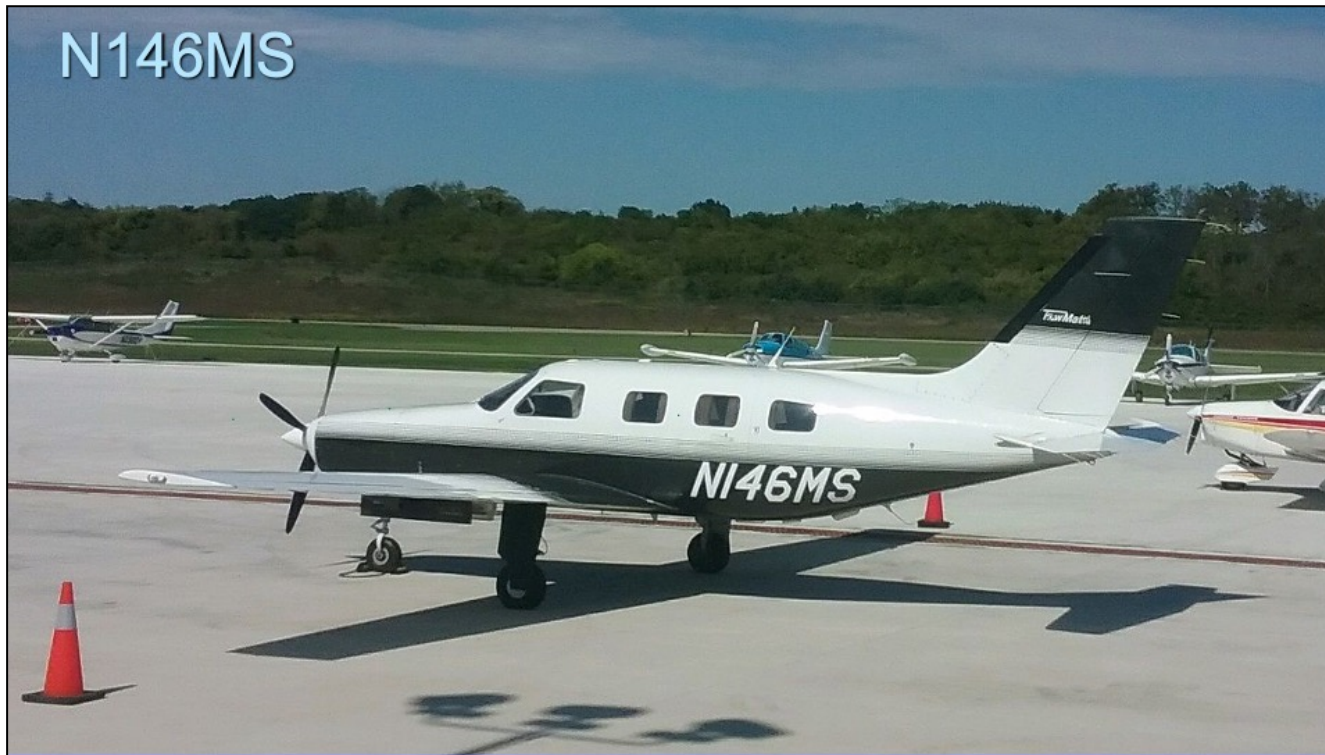
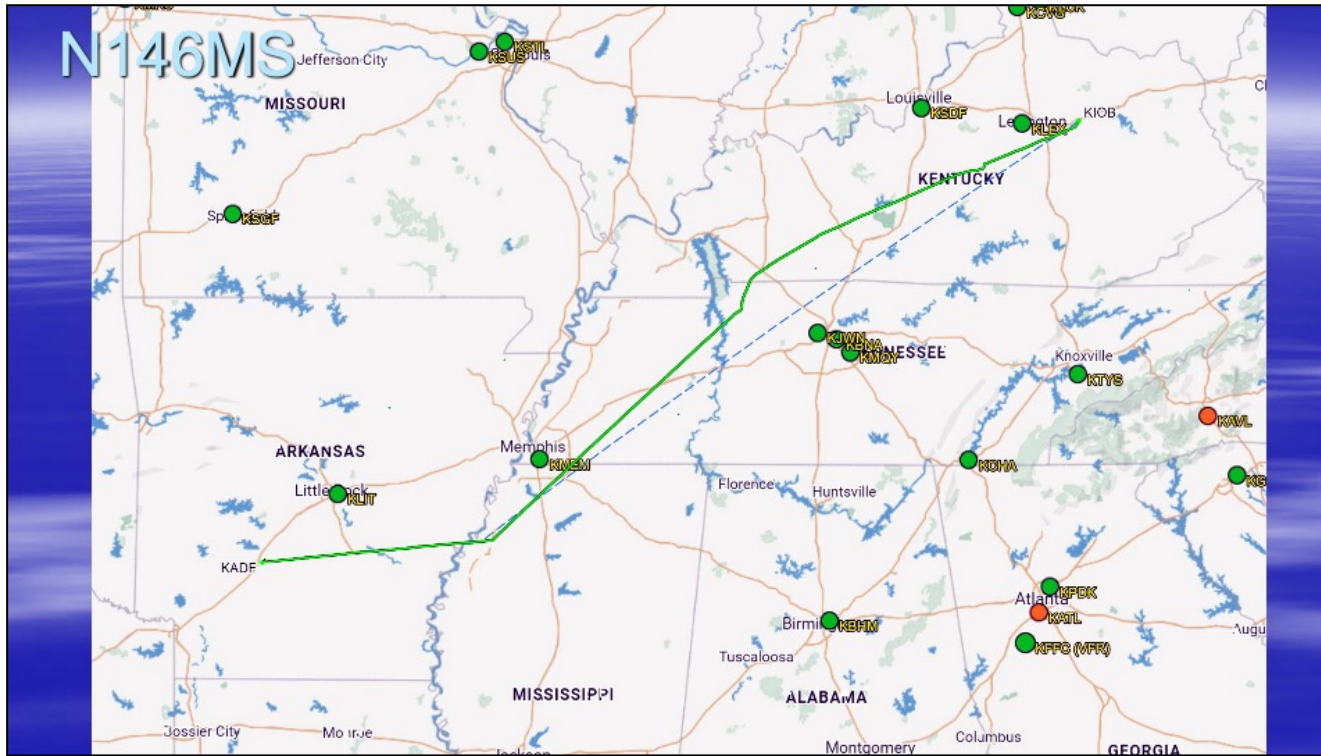
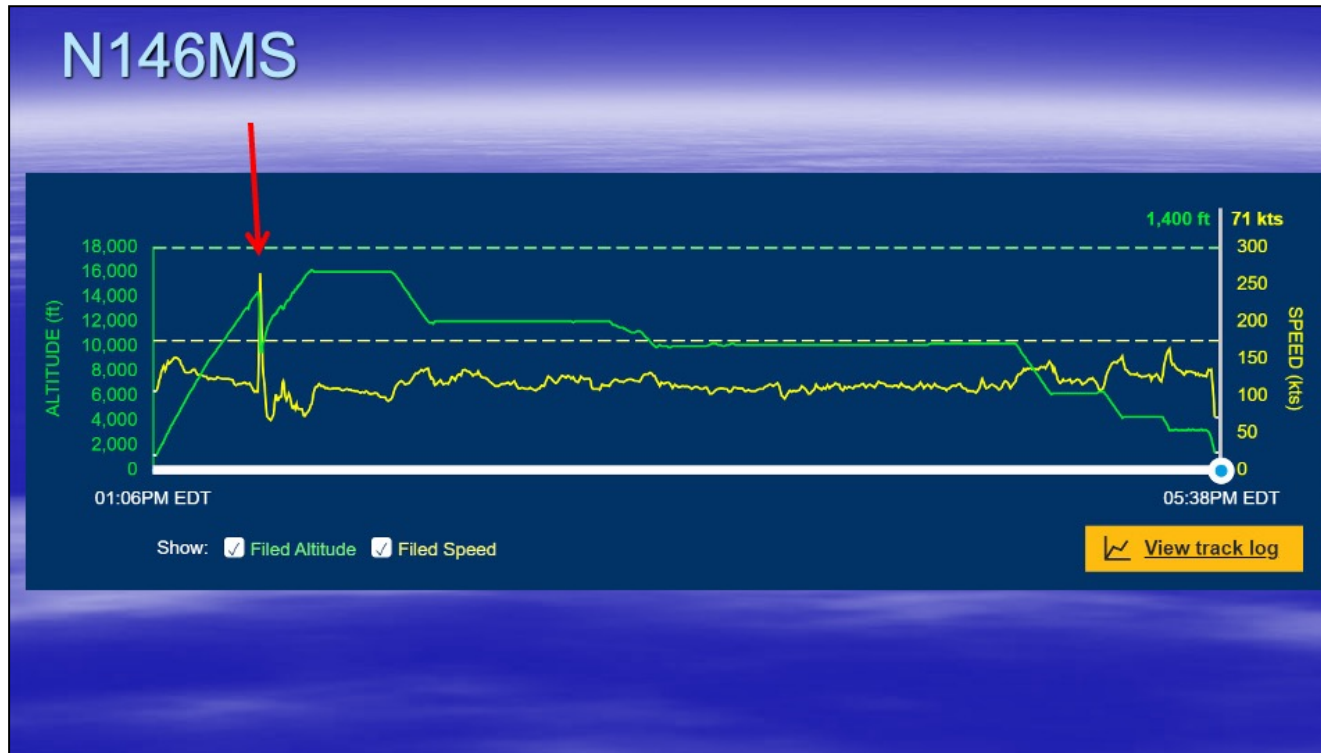
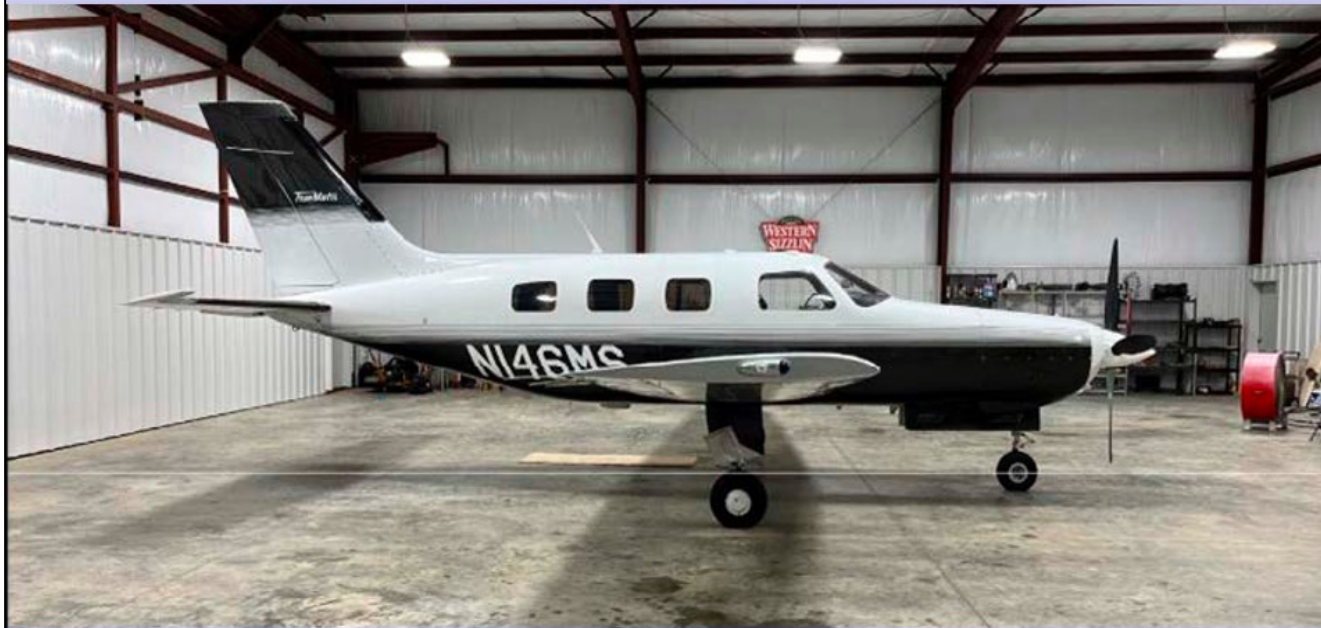
N146MS

This is an '84 Malibu.

As the pilot was climbing thru 14,000 feet in IMC, he noticed his airspeed had dropped by 15 knots.

Remember he was IMC. He didn't see any ice on his wings, but decided to turn on his pitot heat (!!). Obviously the pitot heat should have already been on, but let's continue the story...

Shortly after, his glass panel filled with red X's, and the autopilot flipped off. The plane started shaking, and rapidly descended 5000 feet. The pilot said the plane was shaking so badly, he couldn't read his backup instruments.

The pilot, and subsequently an FAA inspector, did a walkaround, and found some concerning wing issues.

The insurance company sent a mechanic, who diagnosed significant wing root damage, and the insurance company totaled the plane.

You can see the twisting of the wing skin in these pictures.

Of course, we all know the Malibu's pitot heat should have been on prior to entering visible moisture, if not throughout the whole flight.
