Hello! Good morning. Hope you're enjoying our 2024 convention!

My goal today is to discuss the accidents that have occurred since our Colorado Springs Convention last year, and then try to put them into the larger context of our mission of improving safety.

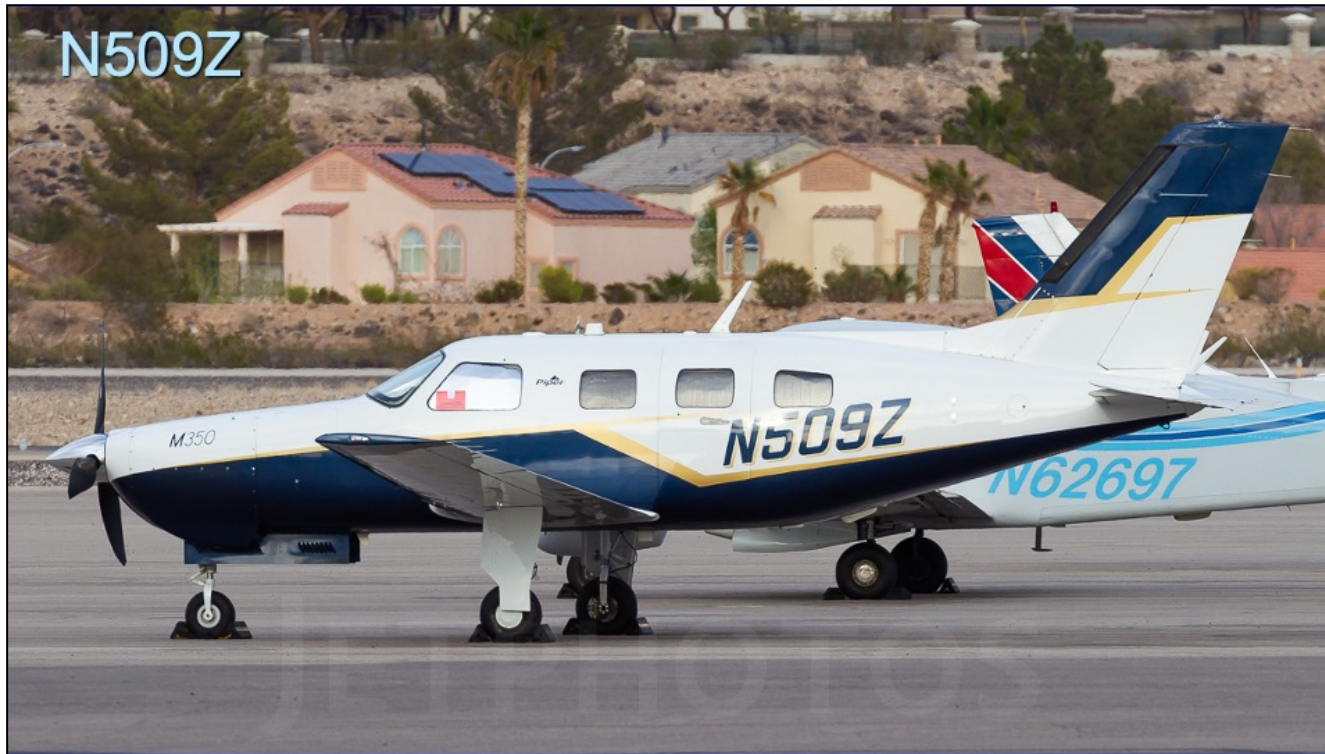
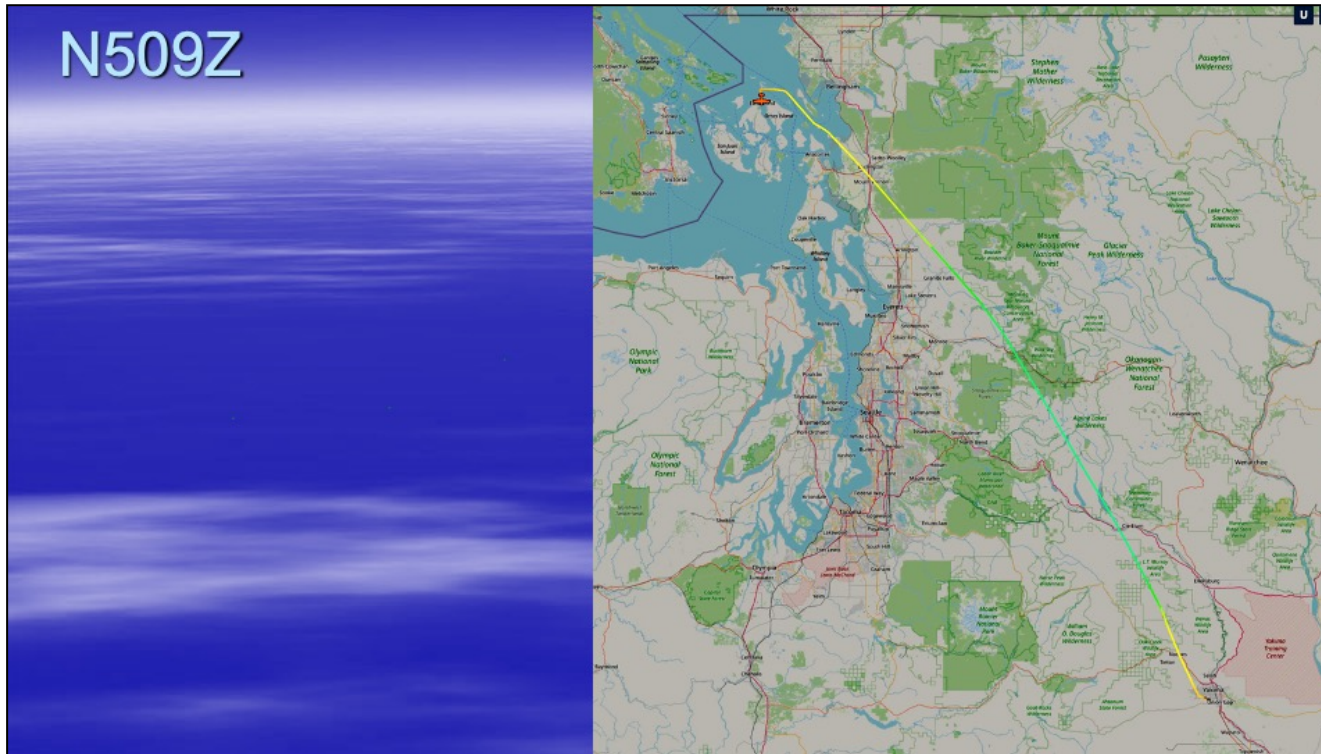
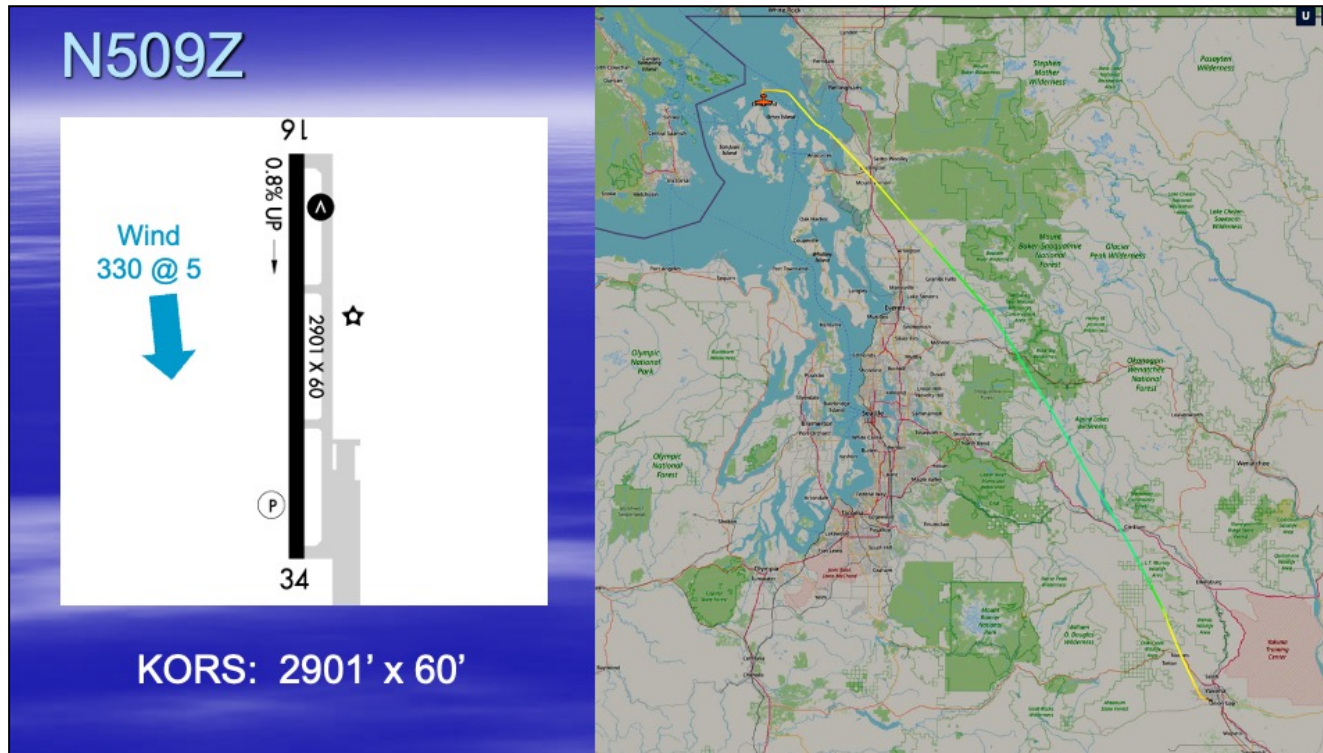
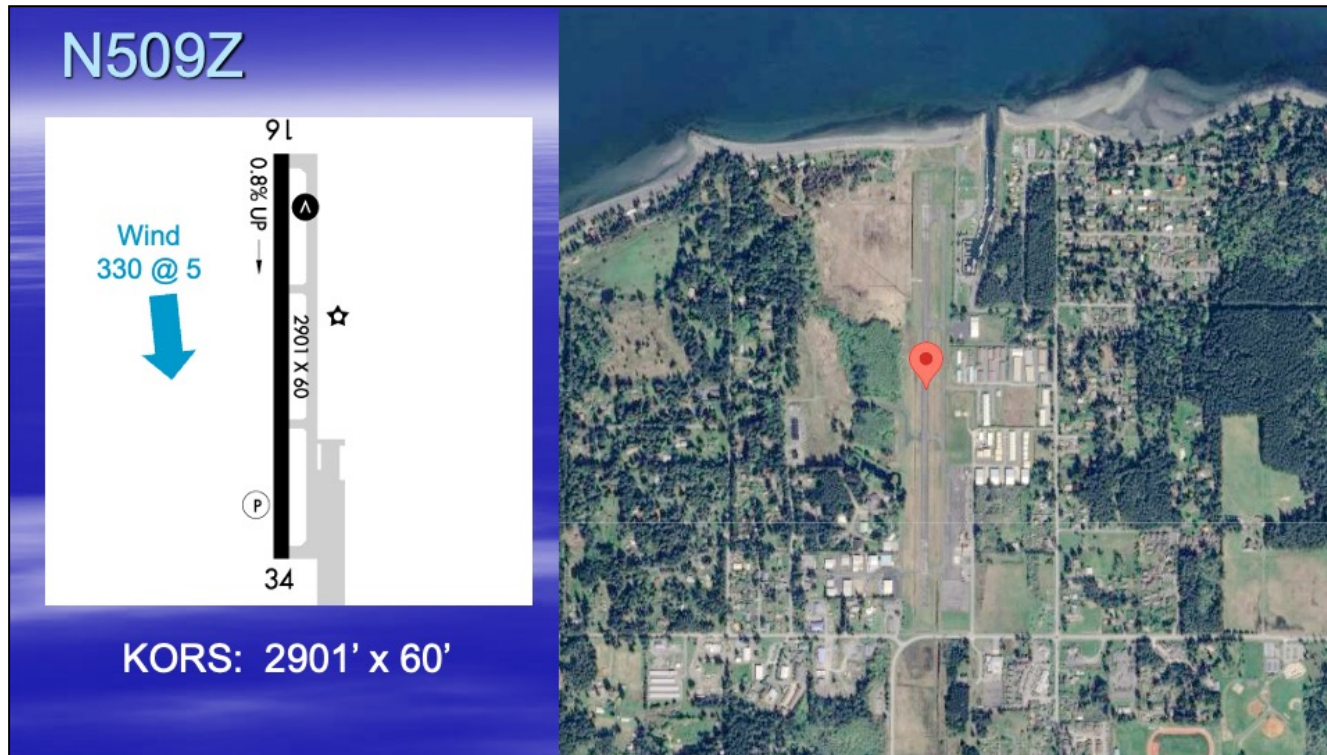
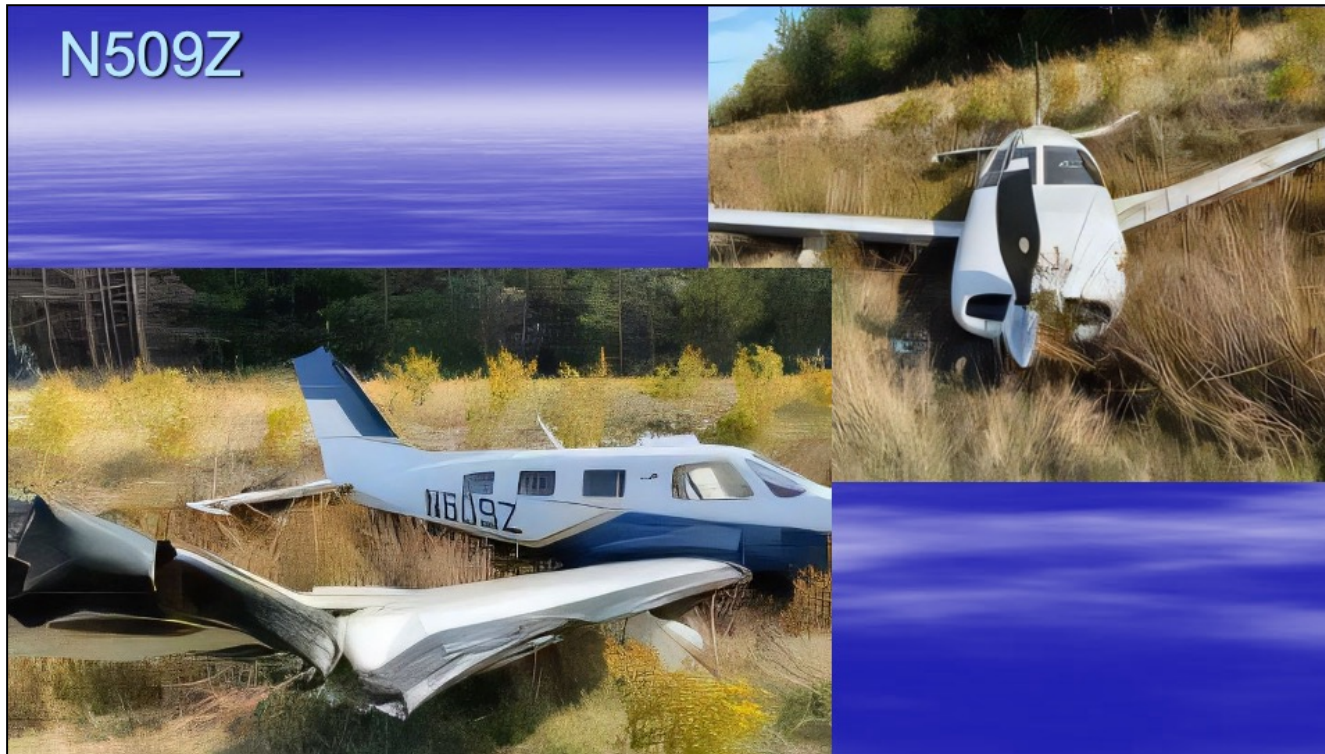
This is a 2018 M350.

The Orcas Island runway is 2900 feet long.

Wind was 330 at 5 kts, and he was landing on 16, so he had a slight tailwind.

The pilot noted on short final, about 25 ft above the runway, that he was too fast for the remaining runway.

He wisely initiated a go-around, but says he raised the flaps prior to establishing a positive climb rate.

His stall warning horn sounded, he lowered the nose, and the airplane hit the ground.

The pilot's unstable approach and improper configuration of the flaps during a go-around which resulted in a stall and subsequent impact with terrain.

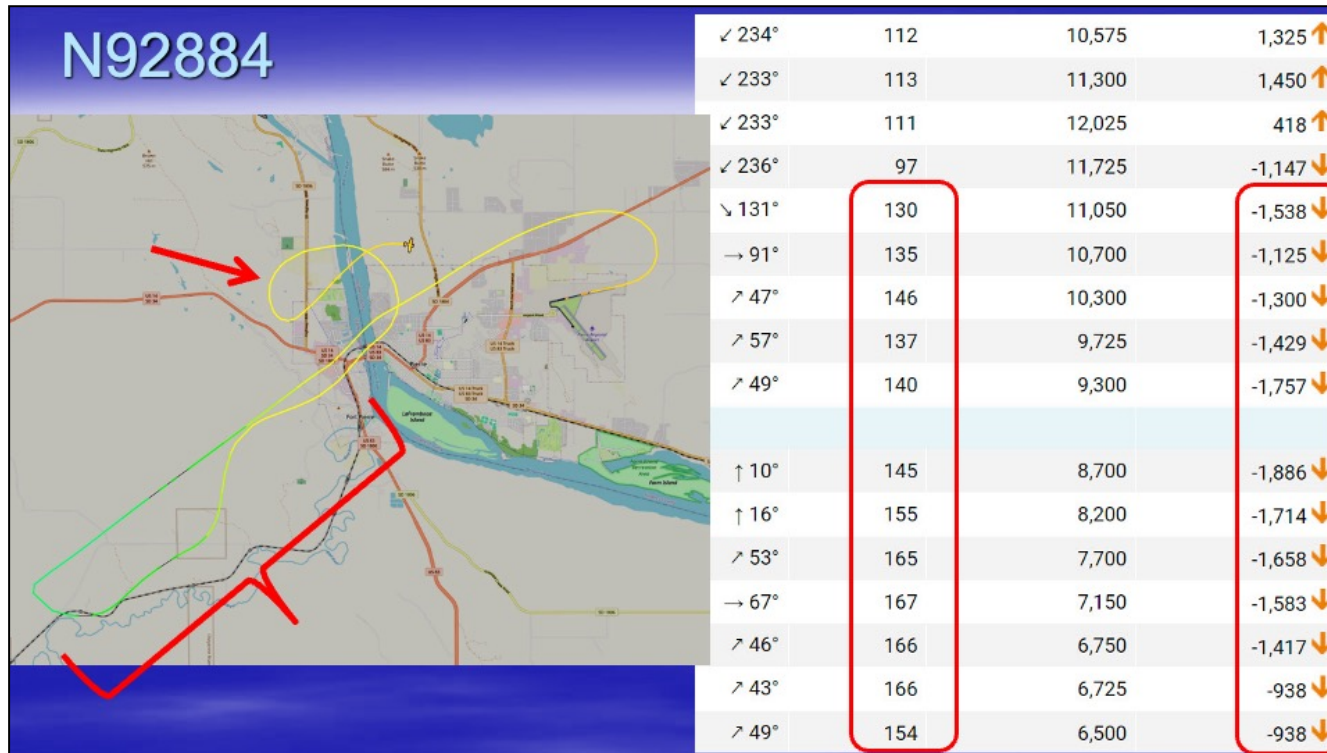
Unfortunately, you can see that most of the trip back towards Pierre, he was too fast, with an excessive engine-out descent rate.

The preliminary report says that after trying a restart, he feathered the prop, so I assume the excessive descent rate was due to speeds ranging from 140 to the 160's.

<CLICK> I don't know what was happening to cause that 360 as he gets lower – that circle cost him 4000 feet of altitude over 4 minutes.

But the end result of an excessive engine-out glide speed and the 360 circle, is that

he didn't have enough altitude to reach the field.

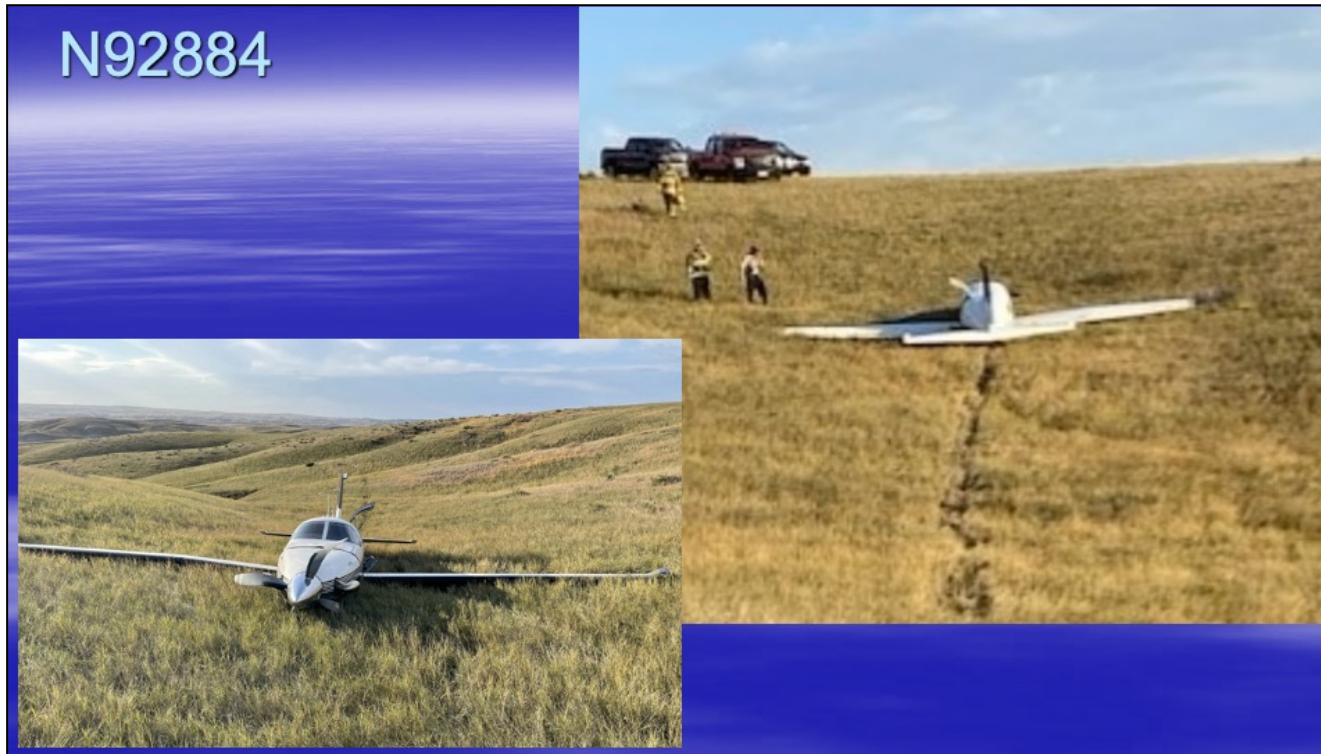
The pilot saw the passenger in back barely breathing, and began CPR, but sadly the passenger didn't survive.

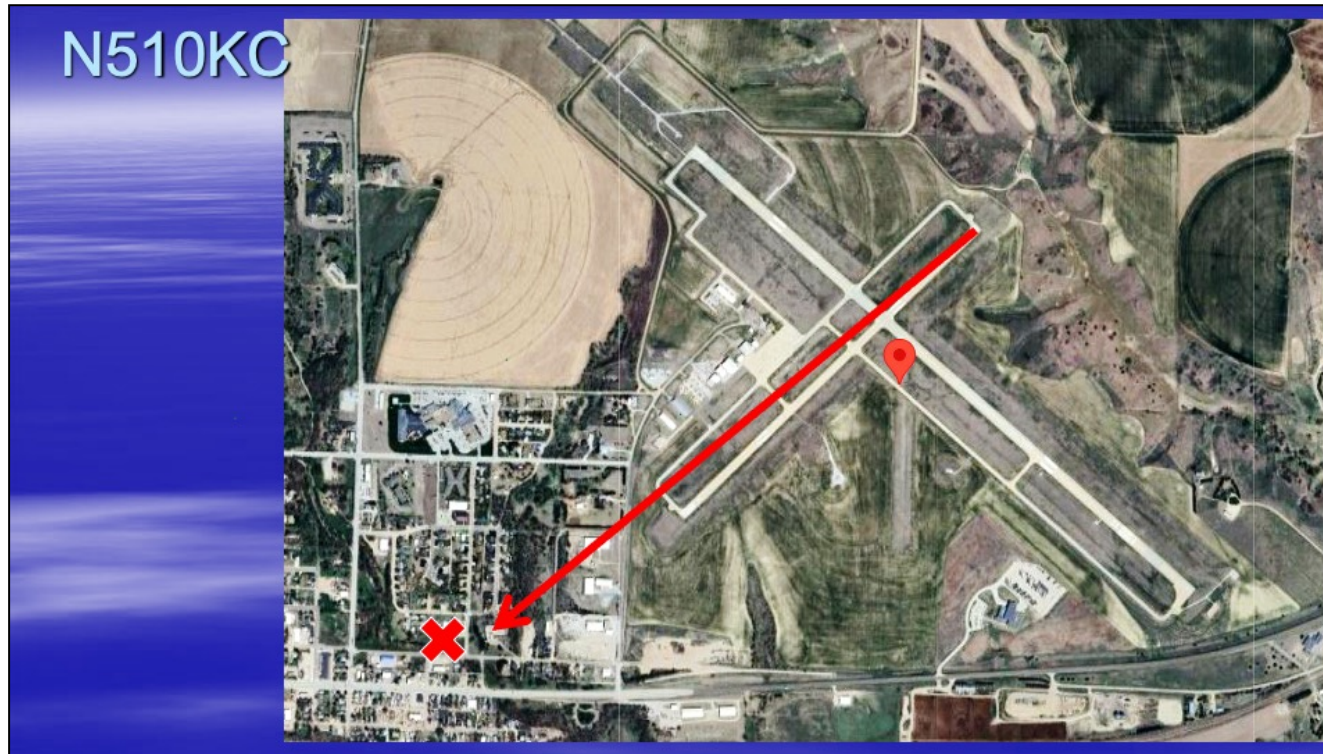
But for currently unknown reasons, the airplane didn't climb, banked left, and descended into trees and terrain.

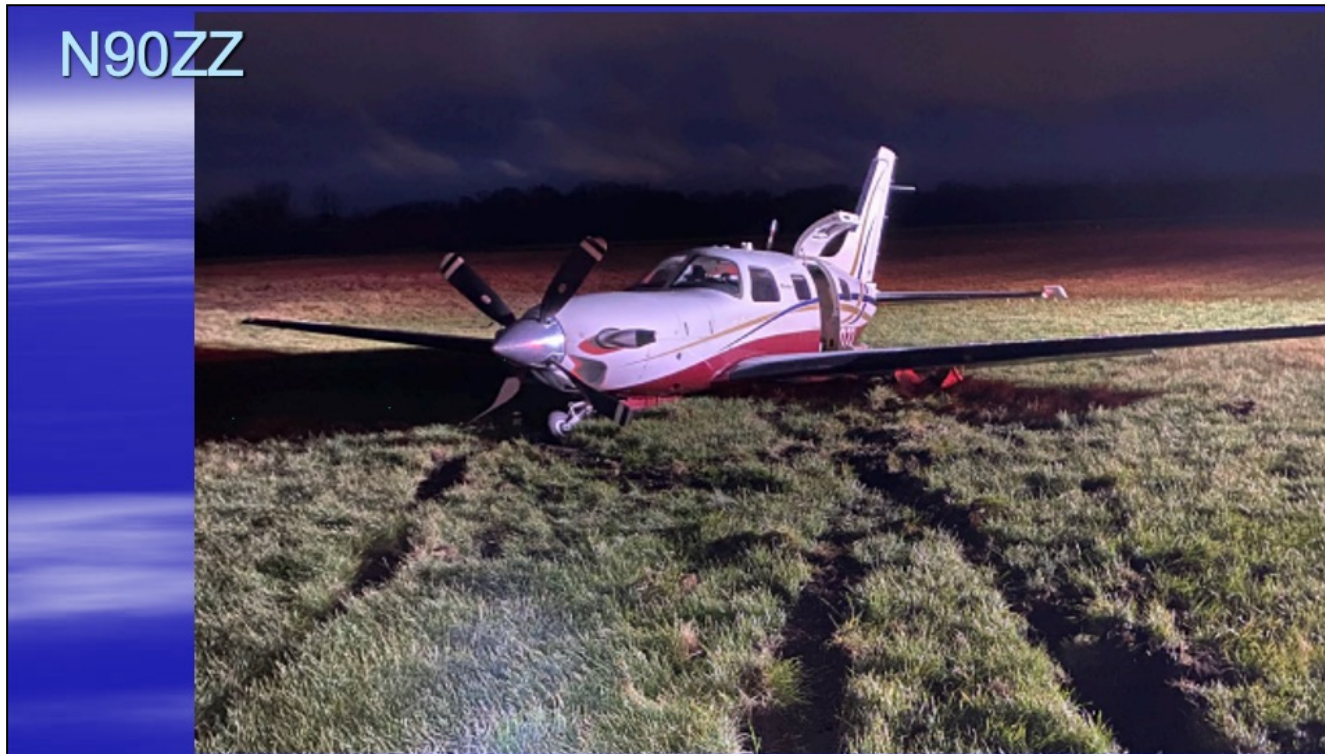
The plane slid and hit the runway threshold.

The left main landing gear separated, the nose gear collapsed.

Post-crash exam also showed substantial damage to the right wing.

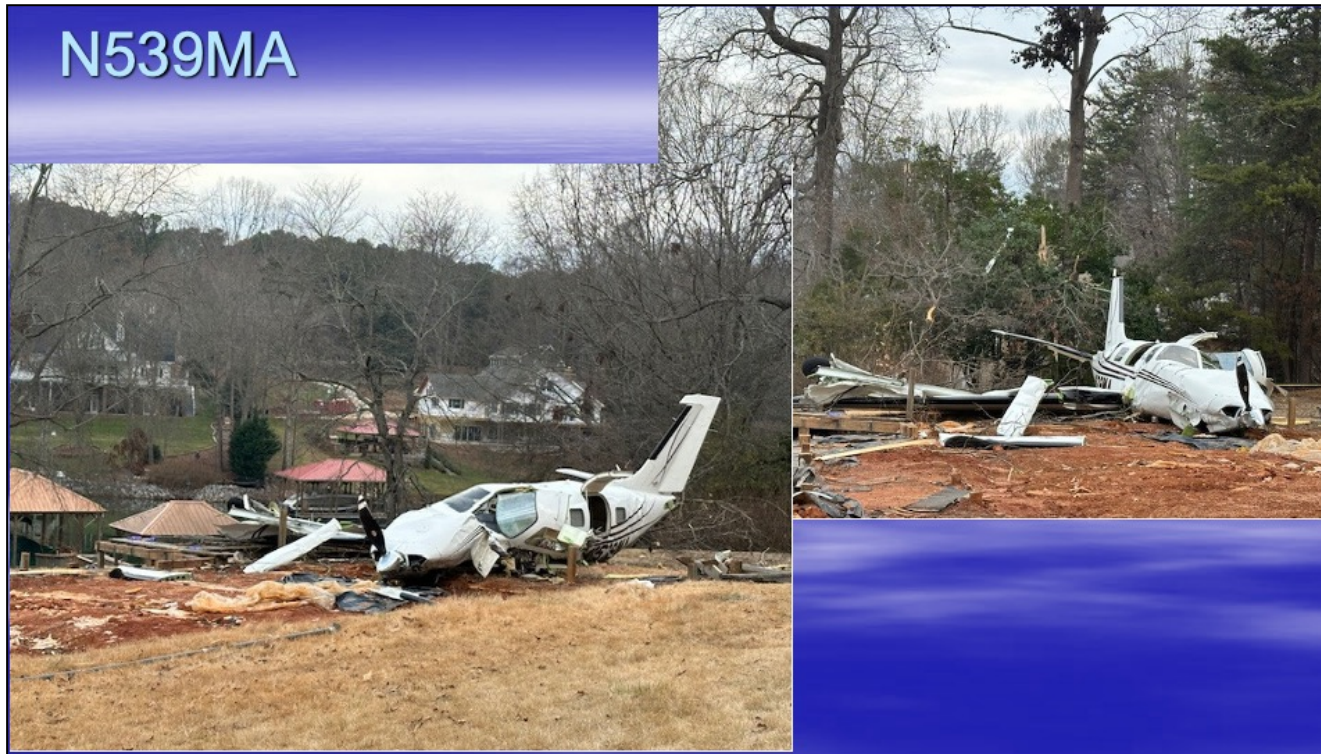
Exam at the scene showed fuel in both wings.

The throttle, mixture & prop controls were all full forward, and the emergency fuel pump was on and working.

The crankshaft was intact.

So basically, there was no smoking gun found, but we know the engine stopped. We just don't know why; I hope the final report will say why.

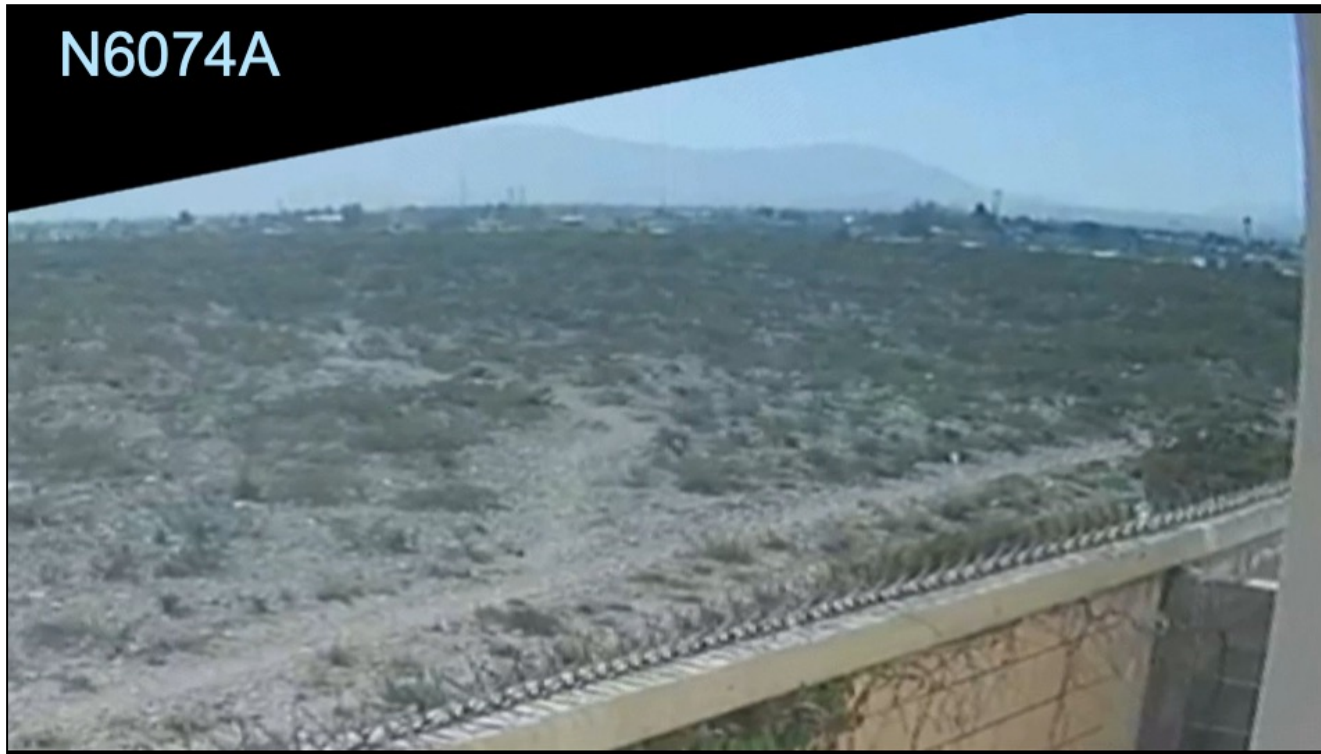
There have apparently been reports that the pilot reported being out of fuel in the Mexican news reports. This is reinforced by the engine sounds in this surveillance video, where the engine seems to cut out. But I have no definitive information.

Regardless, something bad happened on short final.

The plane was descending a bit fast on final, around 900 ft/min.
But otherwise nothing seemed amiss until the last few seconds.

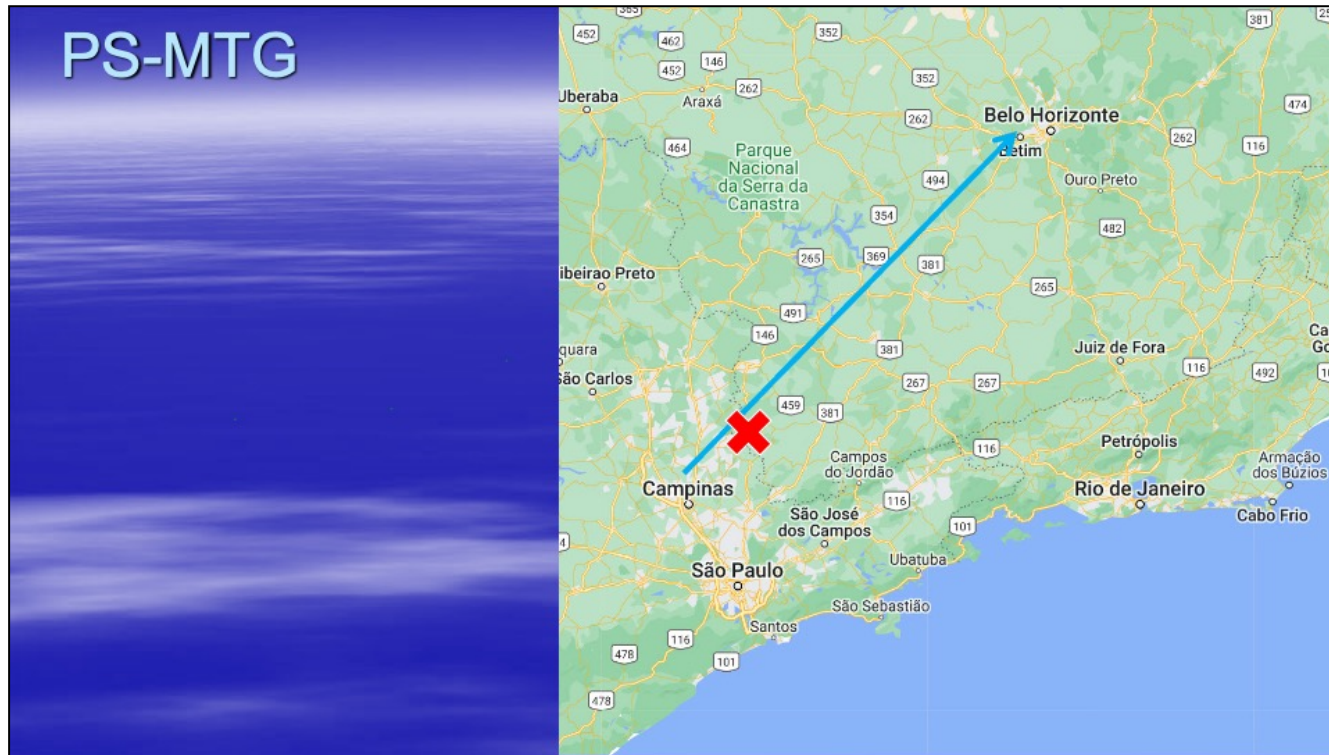
Not very far into the flight, the plane apparently broke up in convective weather.

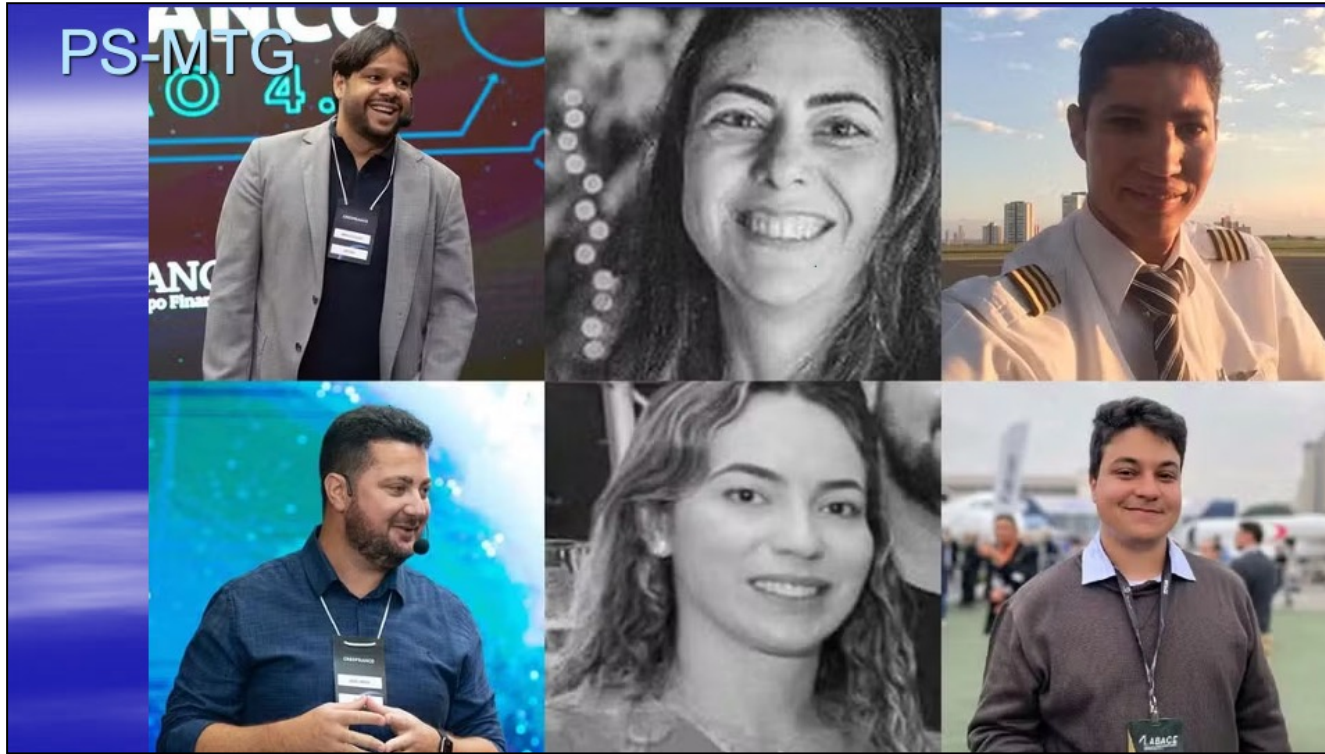
These six people, plus the child of one of the couples, died.

The plane was likely overloaded, and hit bad weather – with a subsequent inflight breakup.

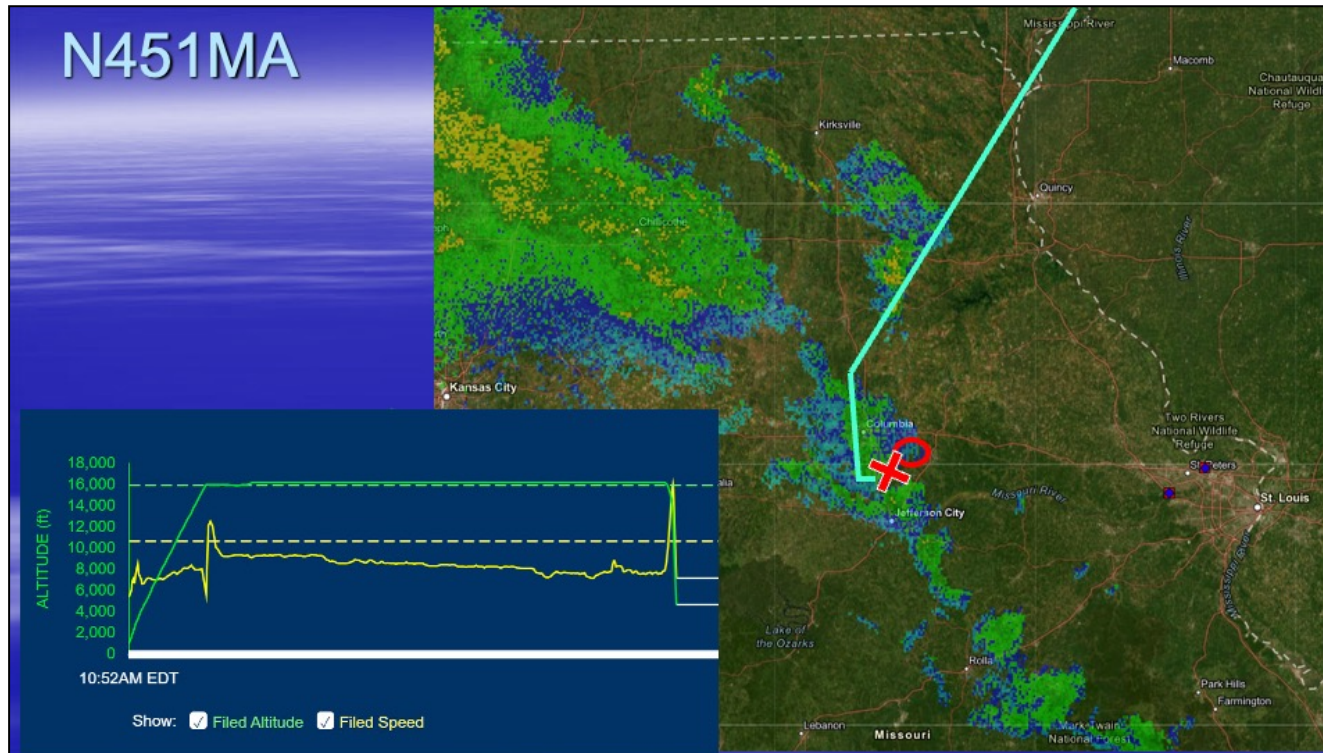
As he gets just southwest of Columbia airport, the plane dives, with a final calculated descent rate of almost 16,000 ft/min, and an ADS-B speed of close to 300 kts (so likely an even higher airspeed).

At that point, the plane has already broken up – the wings and tail pieces were found up to 3 miles from the fuselage.

Joe Casey, on the forums, suggested icing with elevator bridging as a possible cause here, and that seems plausible to me. That could well result in full nose down trim in IMC, with this outcome.

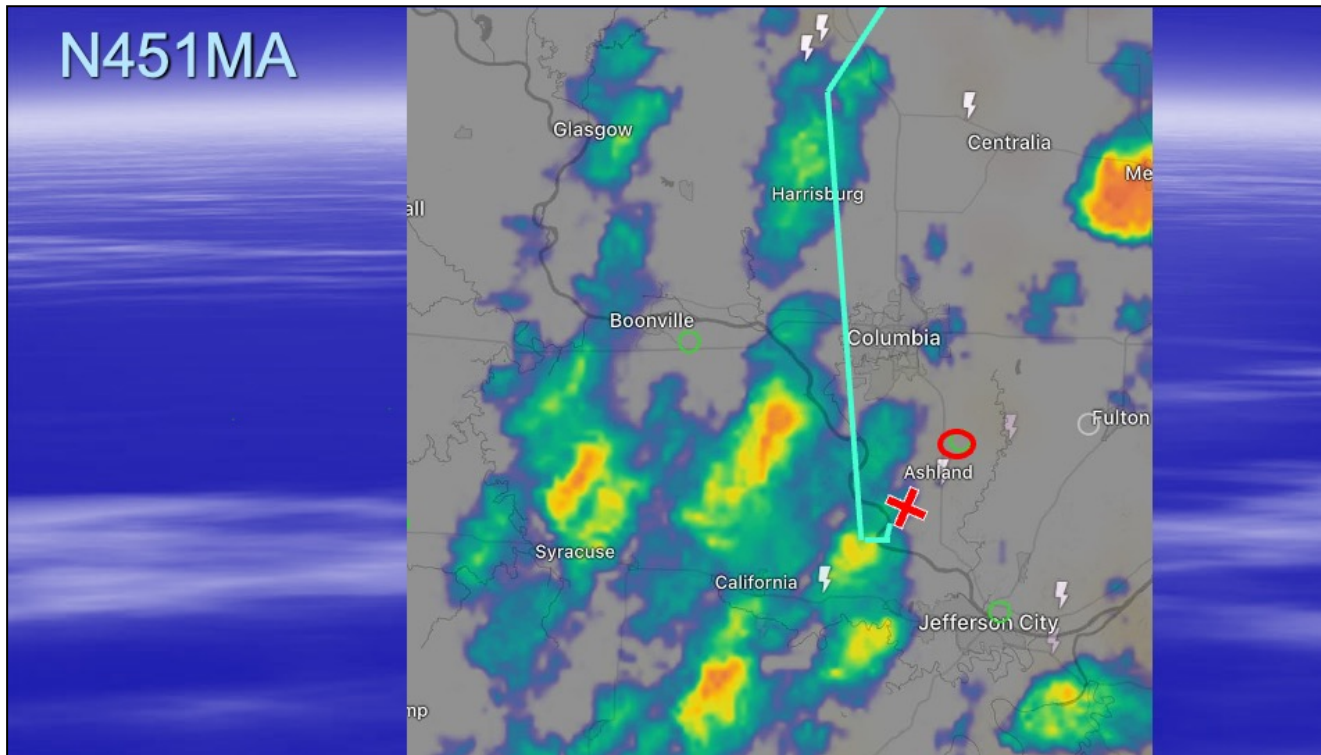
Another possibility, given lightning depictions all over the area, is that he flew into severe turbulence at cruise speed and the plane came apart.

Regardless of cause, the plane shed its outboard wings and tail, and the fuselage hit the ground in an almost vertical path.

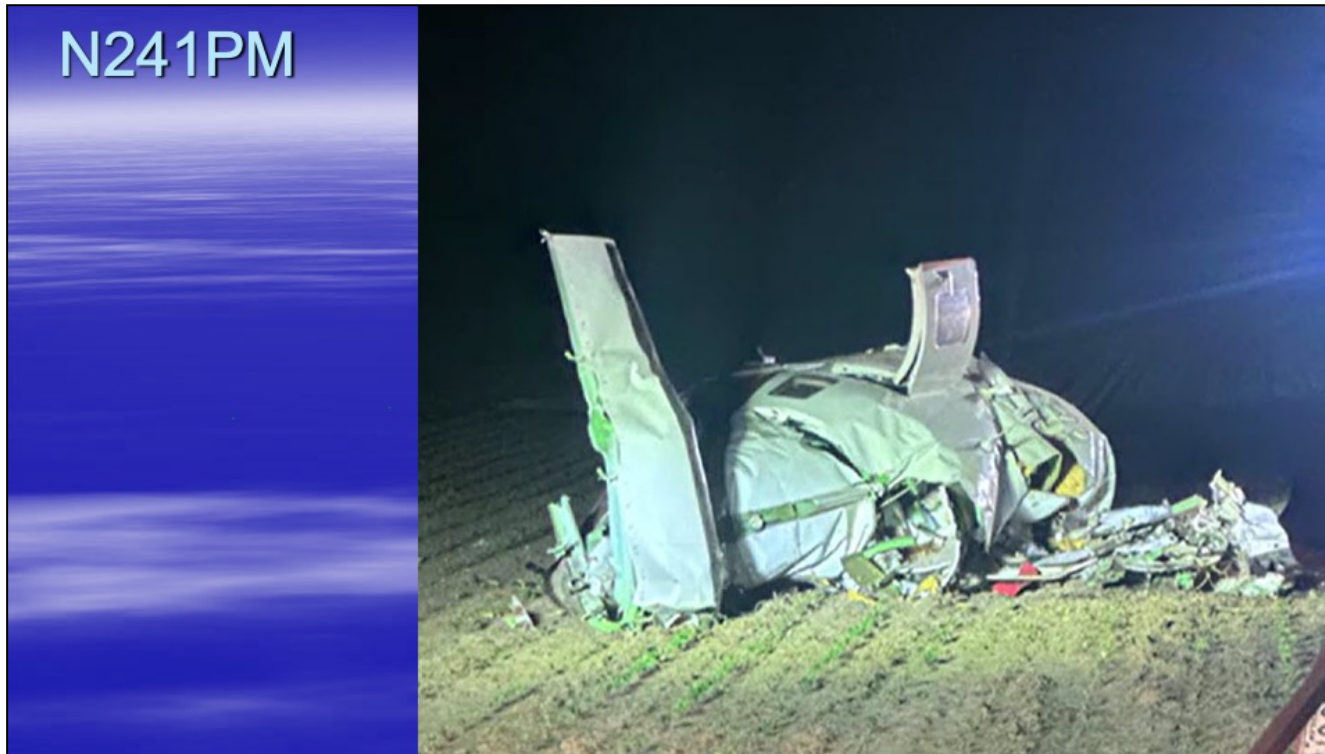
Of course, the two people onboard perished. The two dogs were never found.

Pieces of both wings were found within 80 feet of the fuselage; the tail components were not located.

The landing gear was retracted.

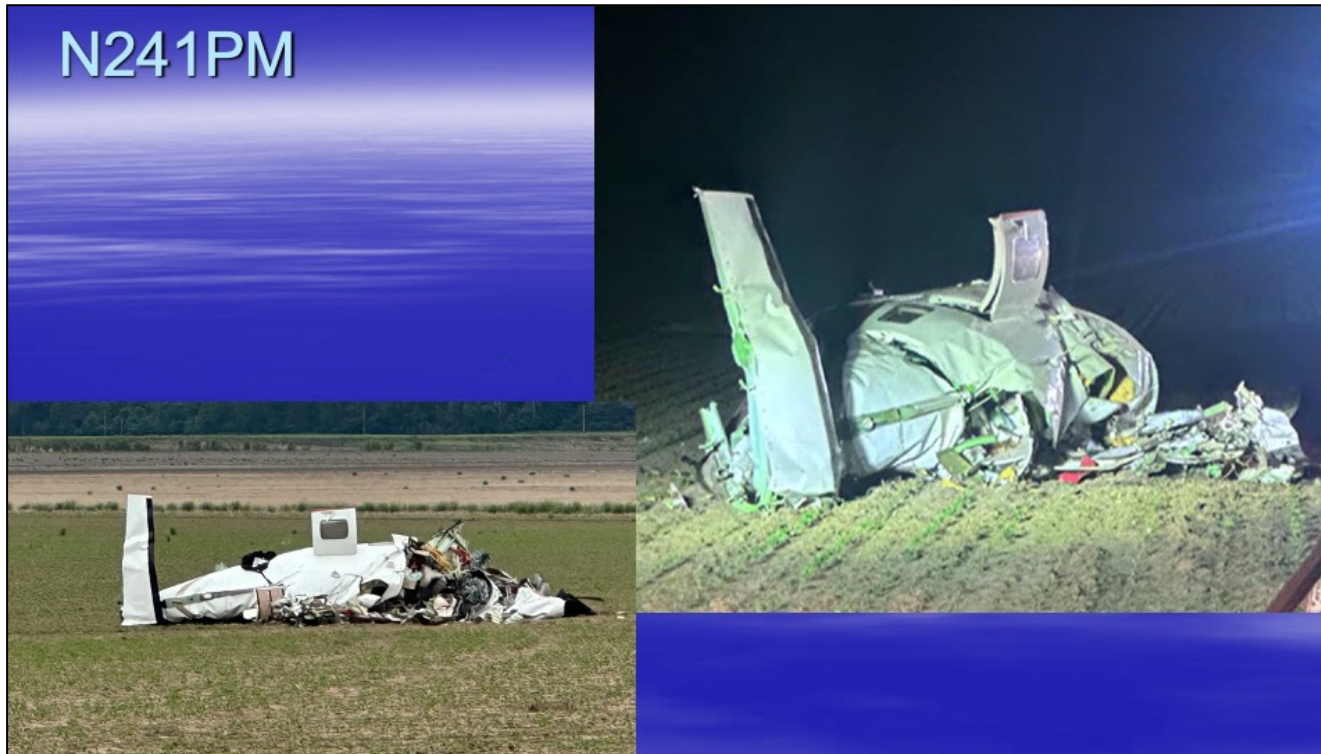
We're left with the same two possibilities as in so many weather associated inflight breakups:

- Too much speed for the turbulence, with an inflight breakup. Retrospective analysis of weather soundings around the time of the accident, indicated strong vertical wind shear between 24,000 and 12,000, with a high possibility of moderate or greater turbulence.
- Possible icing as a contributing factor. (Freezing level was about 13,000 feet.) The pitot heat here was found in the ON position, and was working.

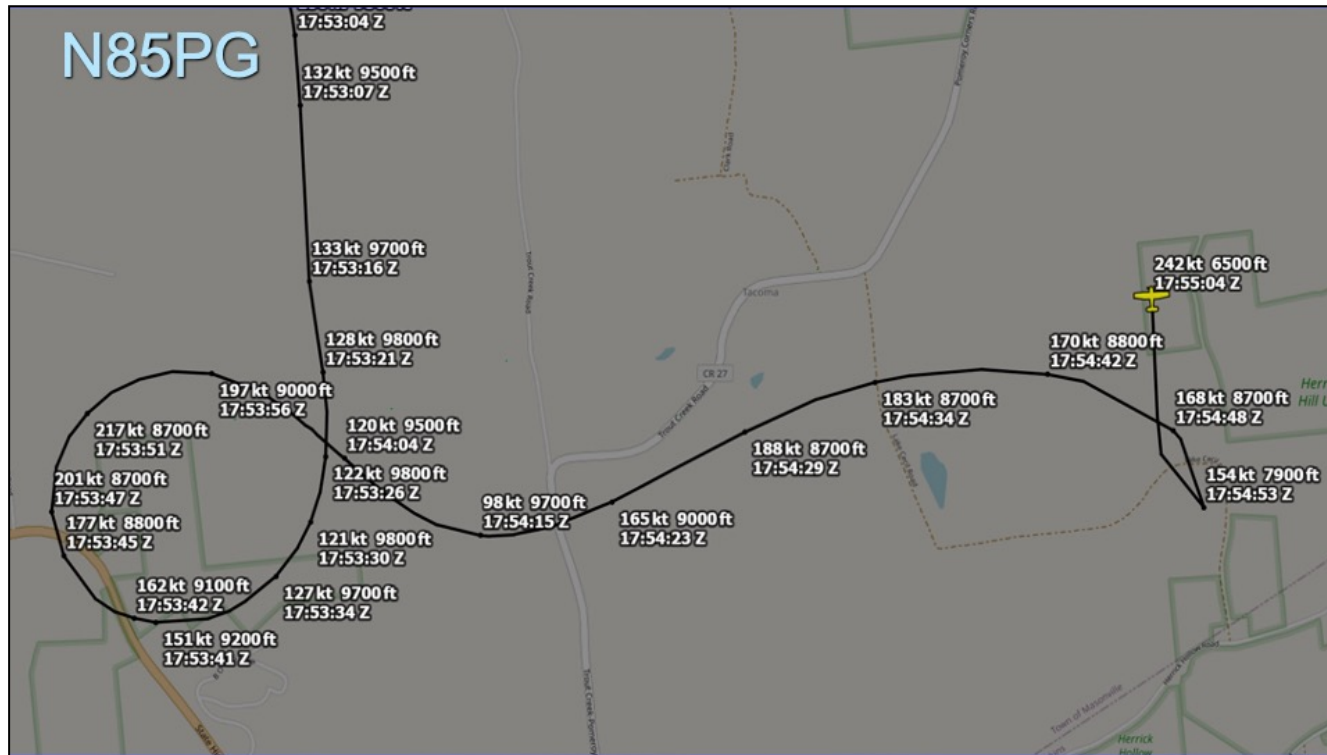
The last radar hit was 1 minute later at 6500 feet and 242 knots.

Most of the tail components were found about a mile from the fuselage. One wing was found half a mile from the fuselage.

The attitude indicator and turn coordinator were rotating at the time of the crash, and the VSI was indicating 4000 ft per minute down. The vacuum pumps were intact and functional.

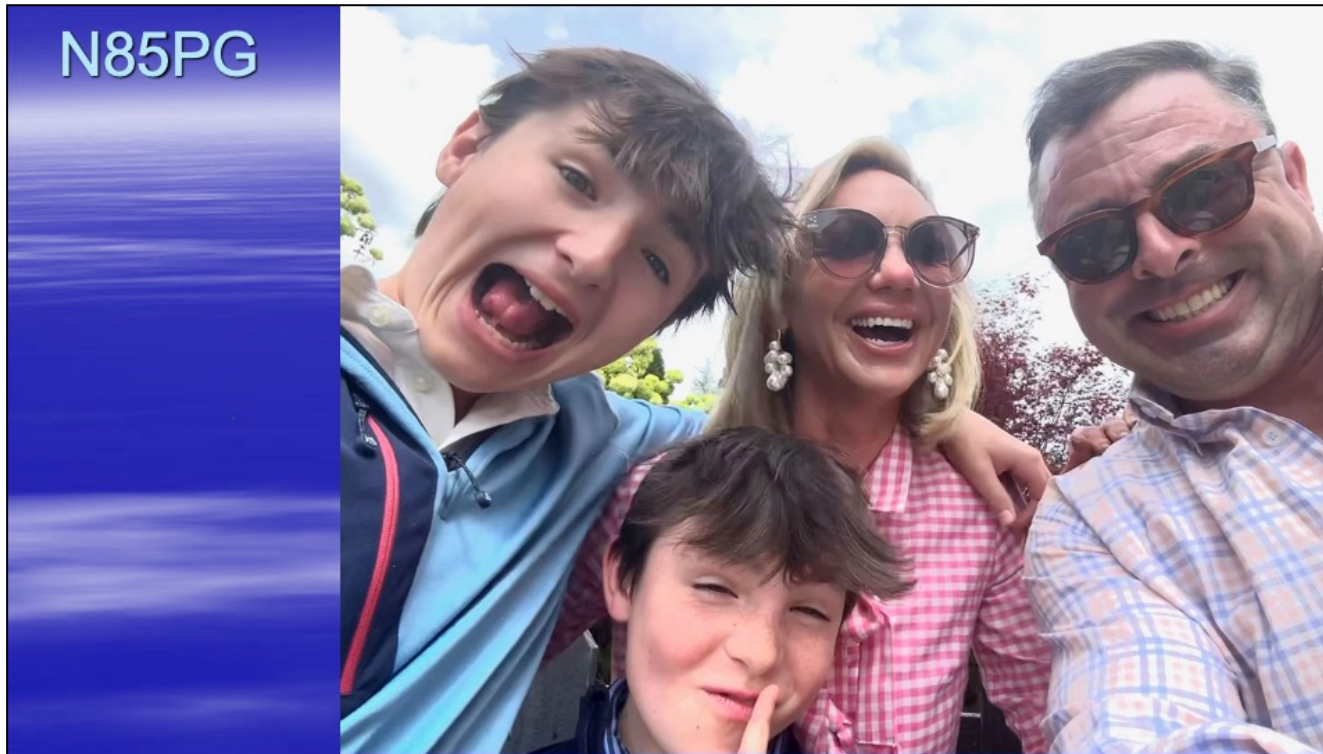
This family and the kids' grandfather, who was the pilot, all died.

To me, a likely cause here is spatial disorientation in significant turbulence and rain, leading to too much speed in turbulence, and an inflight breakup.

The pilot had been flying his PA-46 for years, but I don't know how proficient he was in IMC.

As mentioned regarding the earlier inflight breakups, the imperative is to slow down, which didn't happen here.

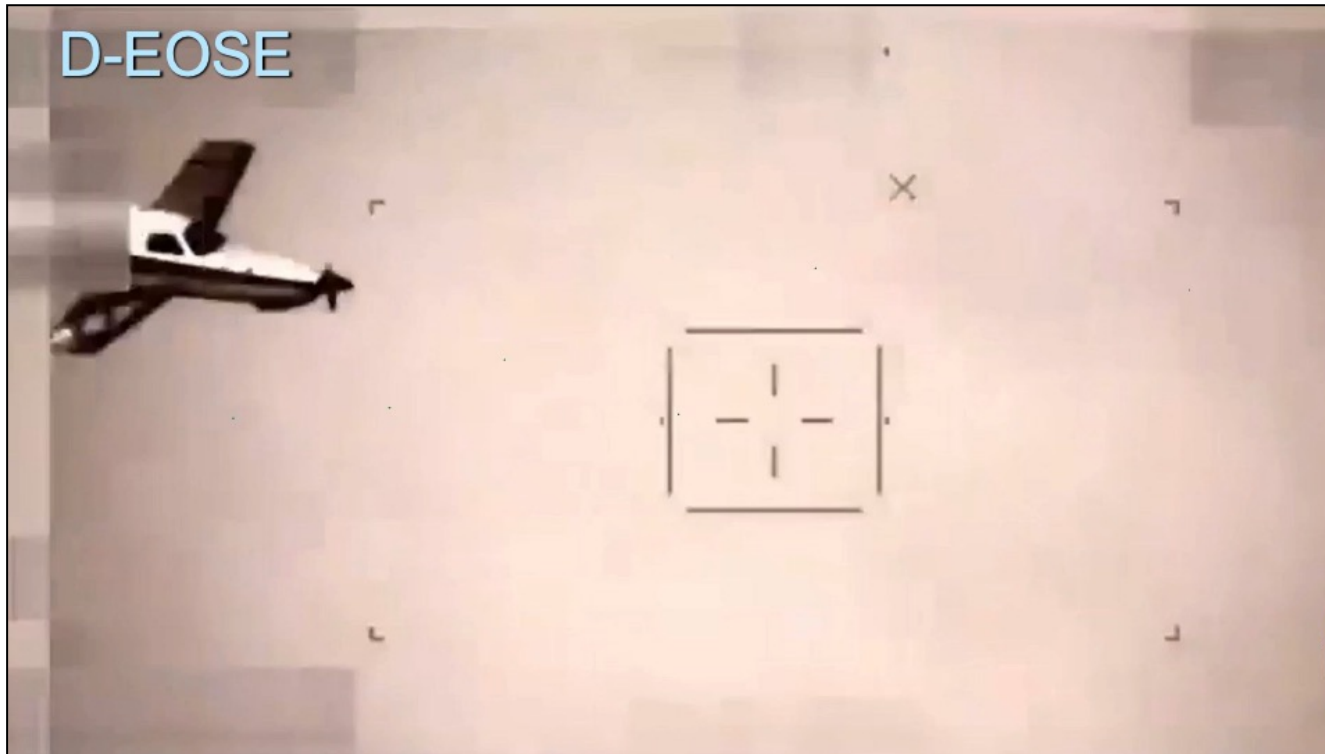
This video is from the Navy ship & drone.

You can see the prop isn't turning.

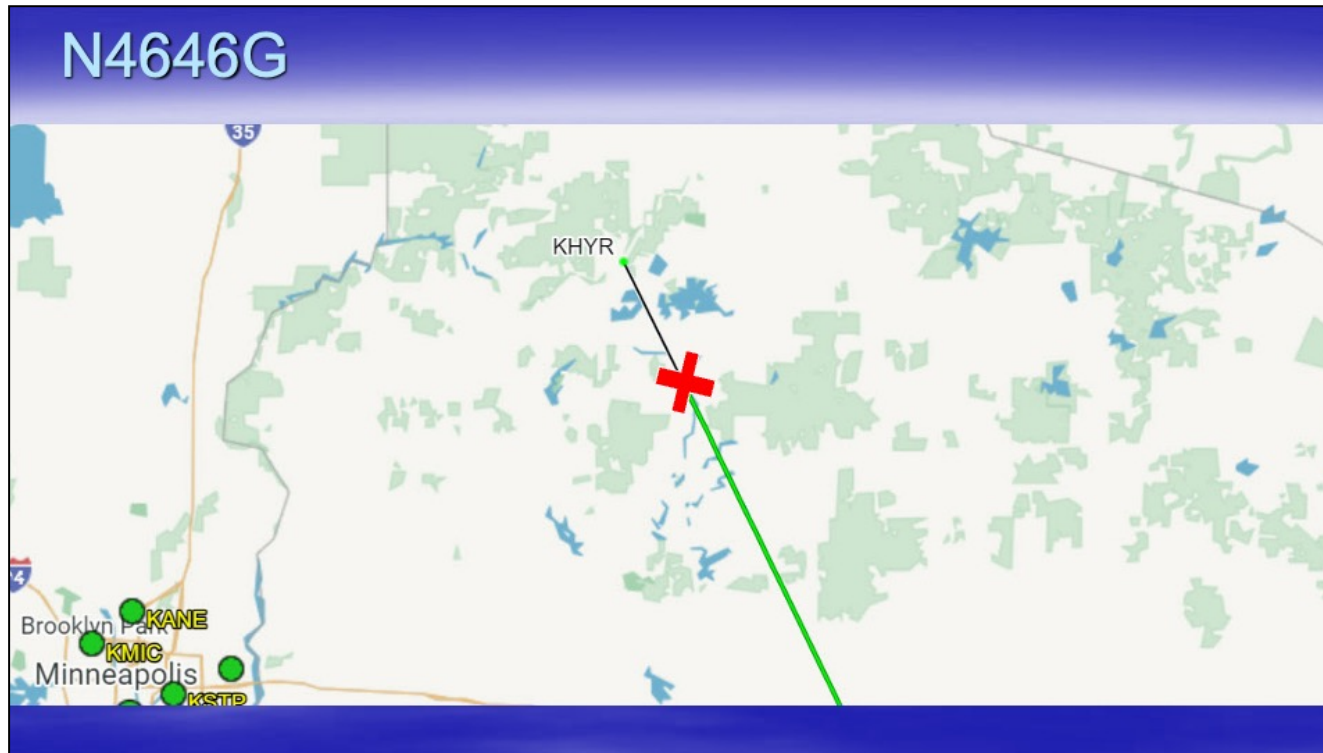
Roughly 25 miles from his destination, the engine lost power.

The pilot declared an emergency, and landed in a grass field, and exited the plane with no injury, though the plane had significant fuselage and tail damage.

The preliminary FAA report hints at fuel leakage at a fuel pressure test port on the Continental 550C engine, but I have no solid information at this time regarding the

cause of the loss of power.
