Hello! Good morning. Hope you're enjoying our 2024 convention!

My goal today is to discuss the accidents that have occurred since our Colorado Springs Convention last year, and then try to put them into the larger context of our mission of improving safety.

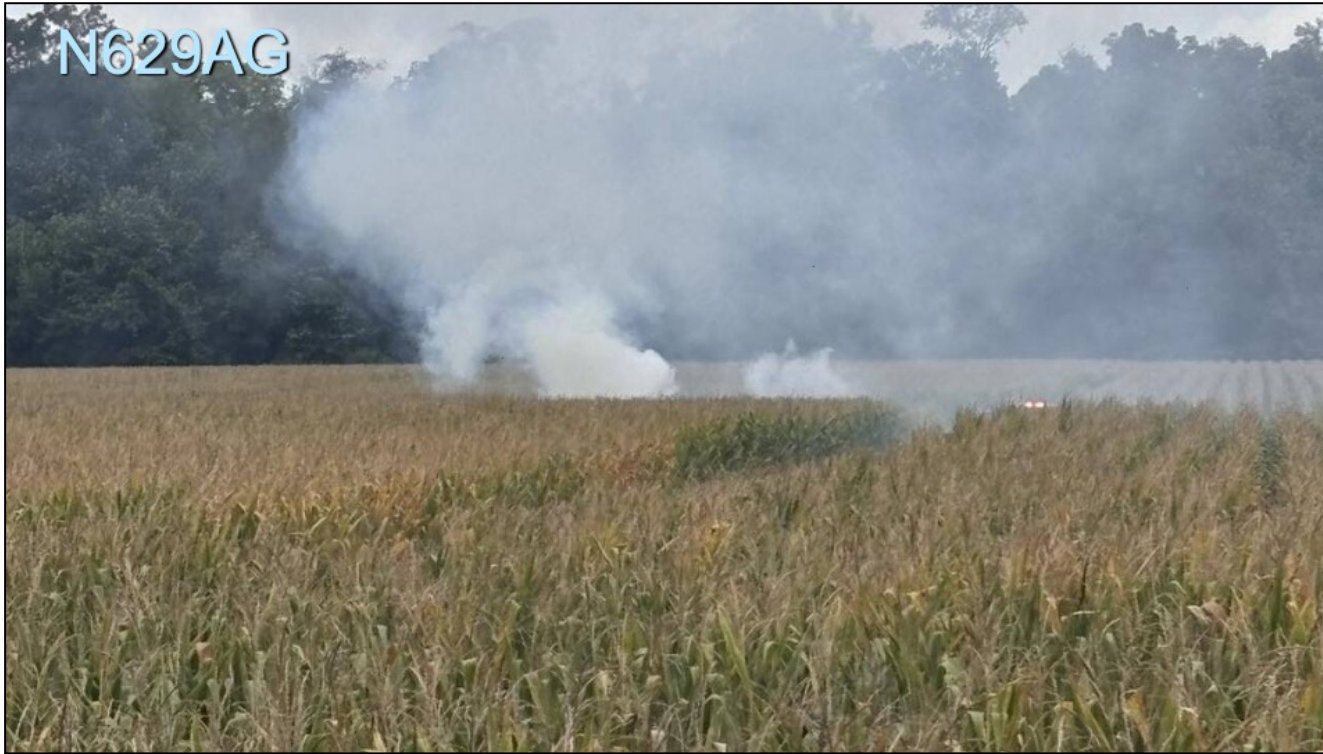
The gear was still extended, and a witness reported seeing the plane “flip over” before “nose-diving into a cornfield” 2 miles southeast of the airport.

This certainly sounds like a stall/spin.

I think it's likely that he had the engine pulled way back for his fast descent, and just forgot, or was distracted, and didn't add power as he climbed on his go-around...

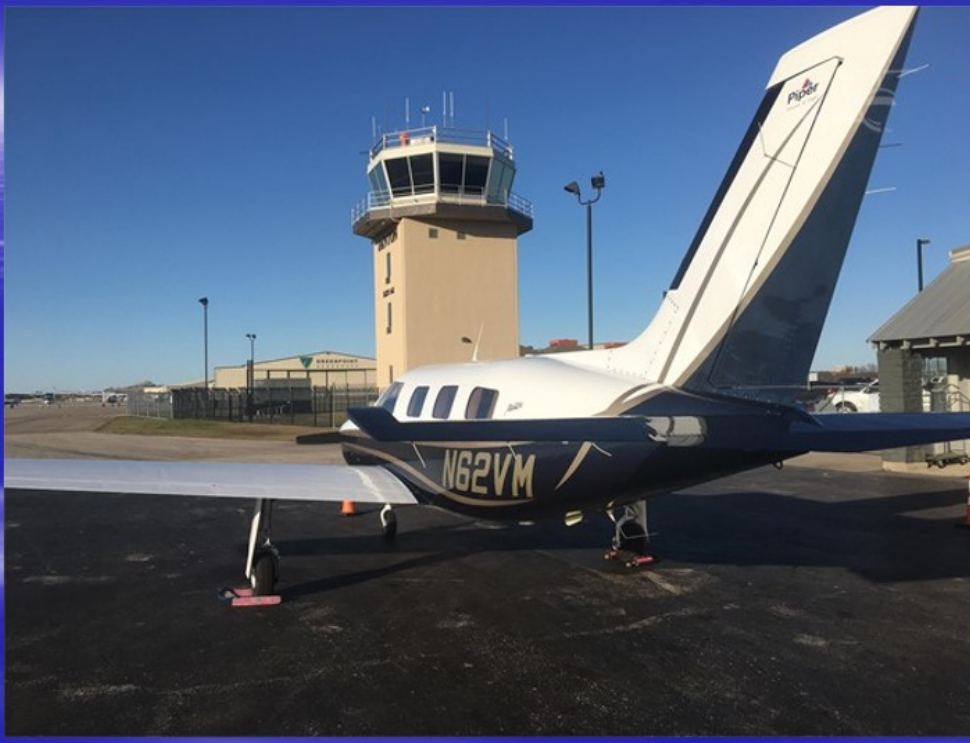
N62VM

And finally, a bird strike.

This is a 1986 Malibu in excellent shape, with a relatively new paint job.

considered significant damage, but I don't know if the wing damage was more extensive.
